SNO+ update for SEF

Christine Kraus
February 11, 2026

Internal Calibrations – July to November 2025

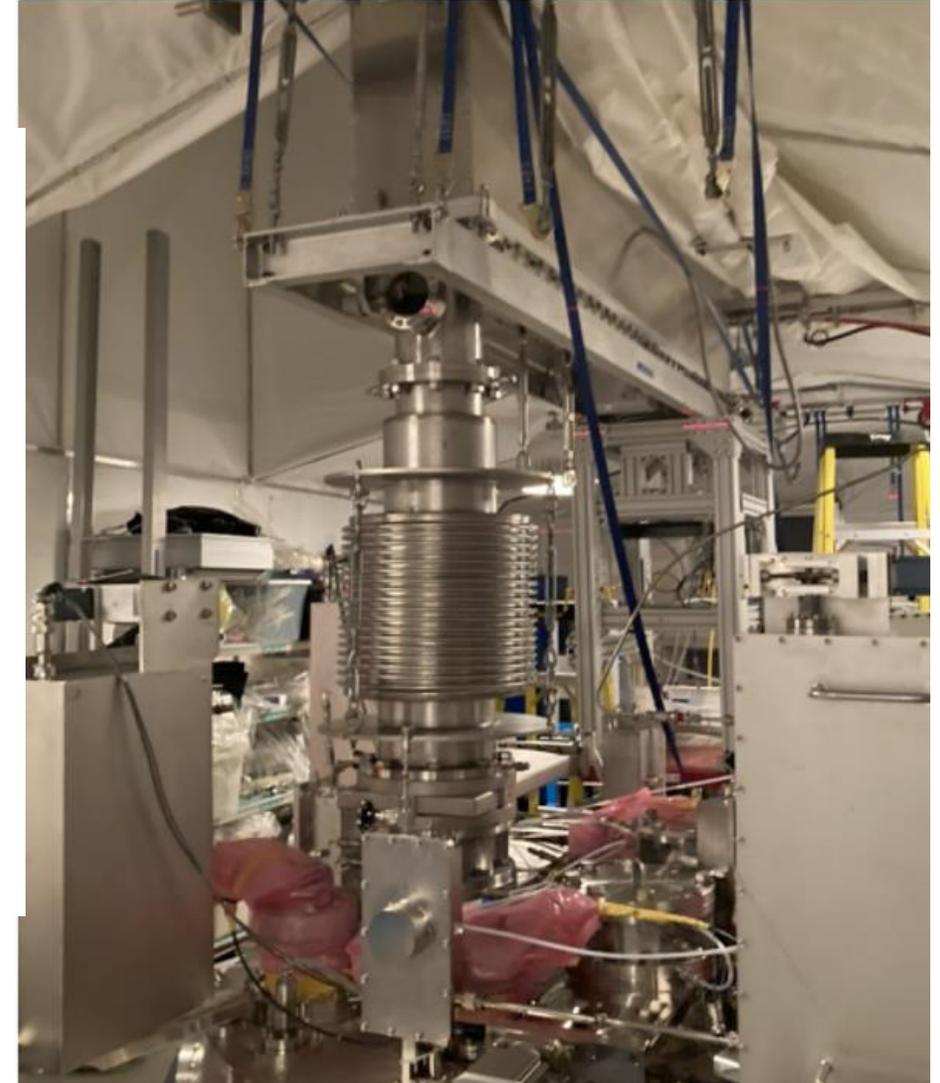
- Key components:
 - ▶ Umbilical retrieval mechanism
 - ▶ Source Bellows
 - ▶ Lifting system
 - ▶ Umbilical
 - ▶ Source Connector
 - ▶ Source (AmBe/Laserball)
 - ▶ Sideropes
 - ▶ Motor boxes
 - ▶ Guide tubes

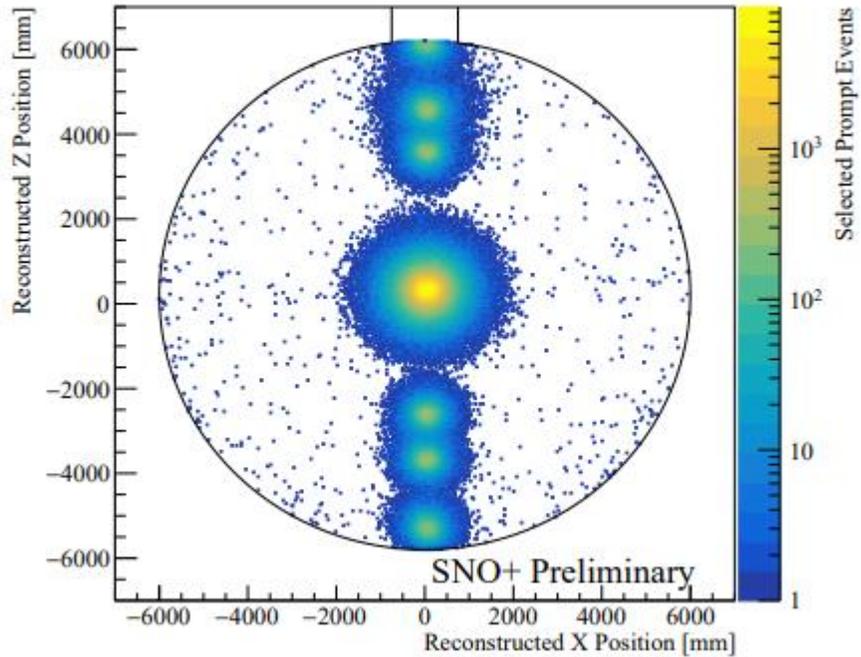
AmBe source

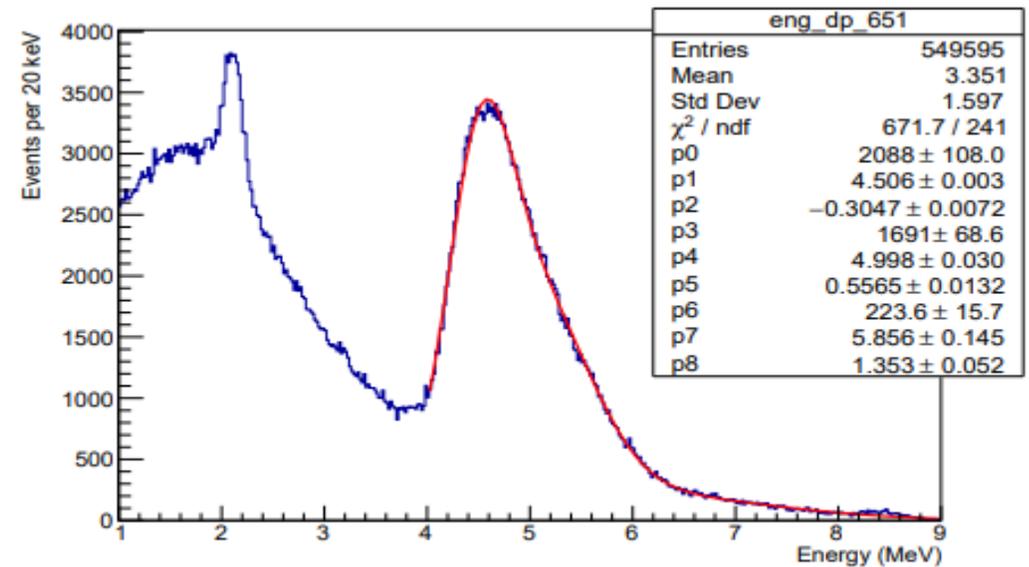
Energy Spectrum

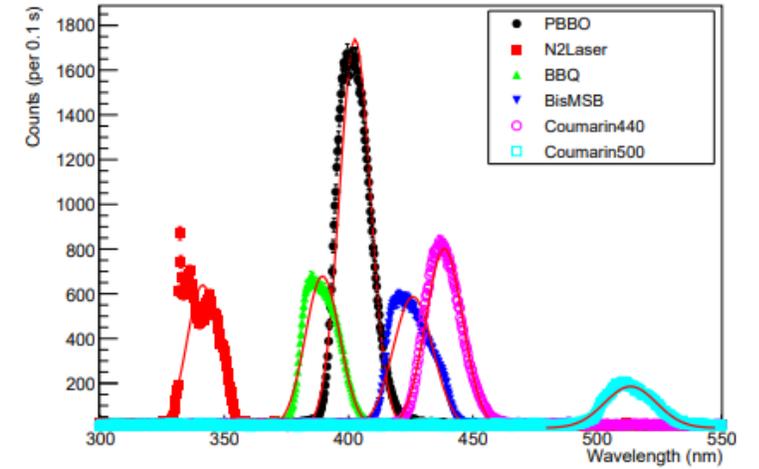
Laserball

Analysis work ongoing on all calibration data taken.

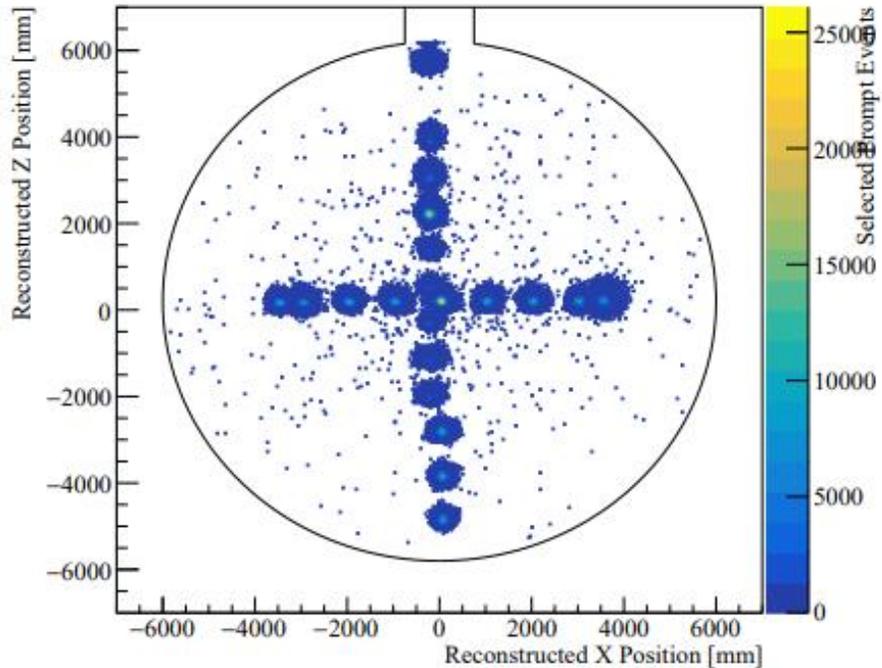
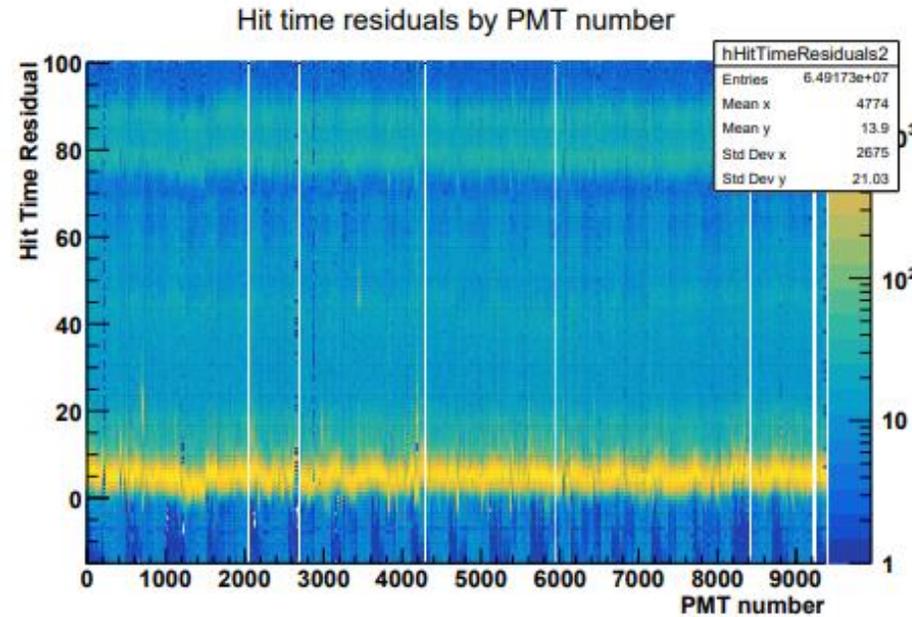
Dye Laser spectra

Internal Scan

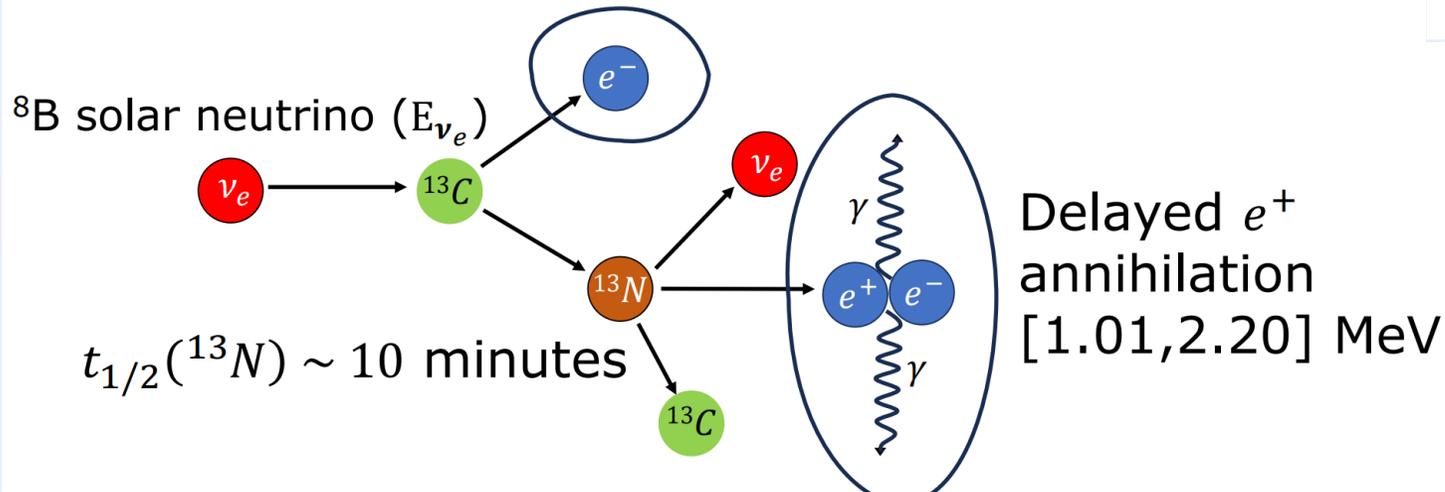
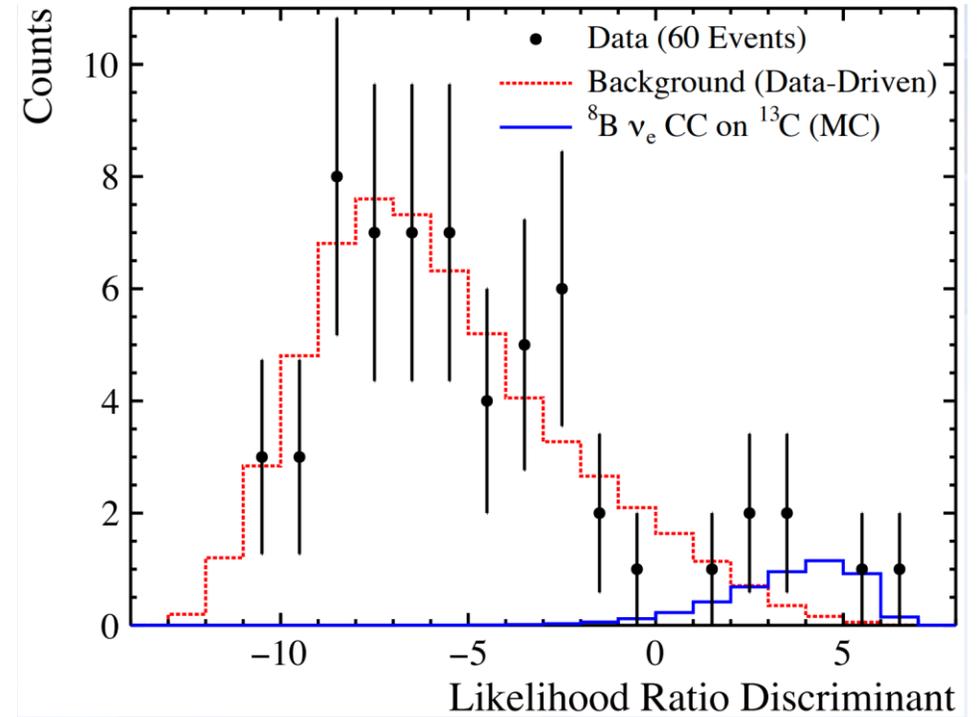
1.1% ^{13}C \rightarrow 8 tonnes in SNO+

Prompt e^- ($E_{\nu_e} - 2.2$ MeV)

4.2 sigma with 230 days
Got lots of media attention
First time measurement

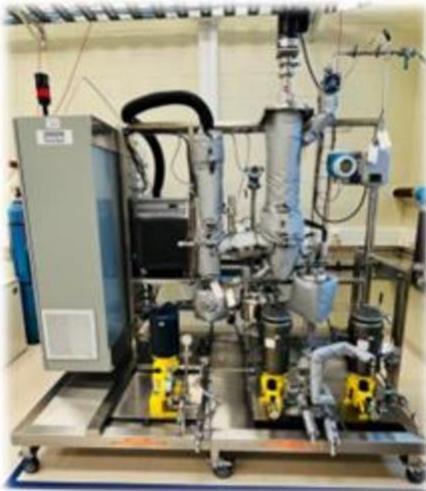
DDA Distillation

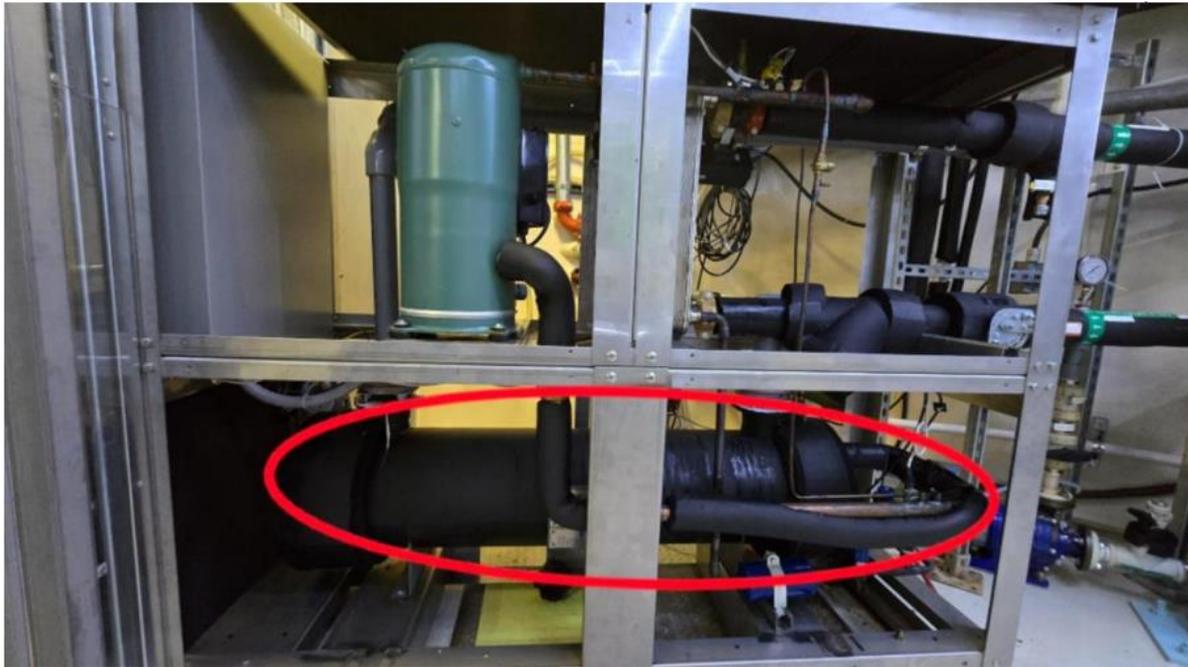
- Chiller broke last summer – hopefully back this month ... needed to complete test batches

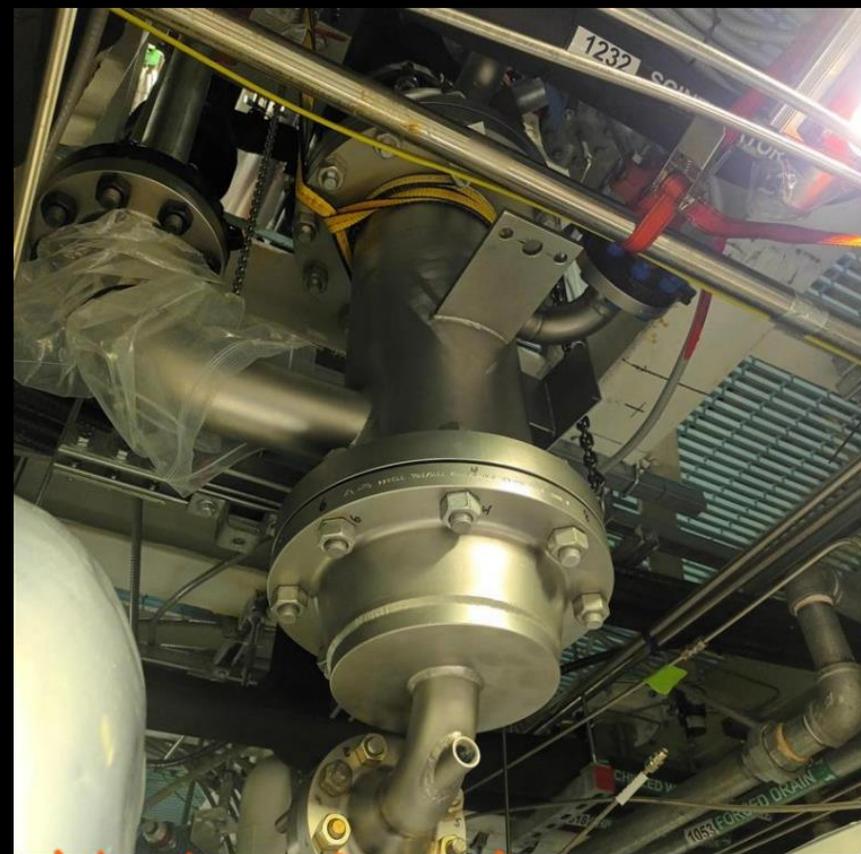
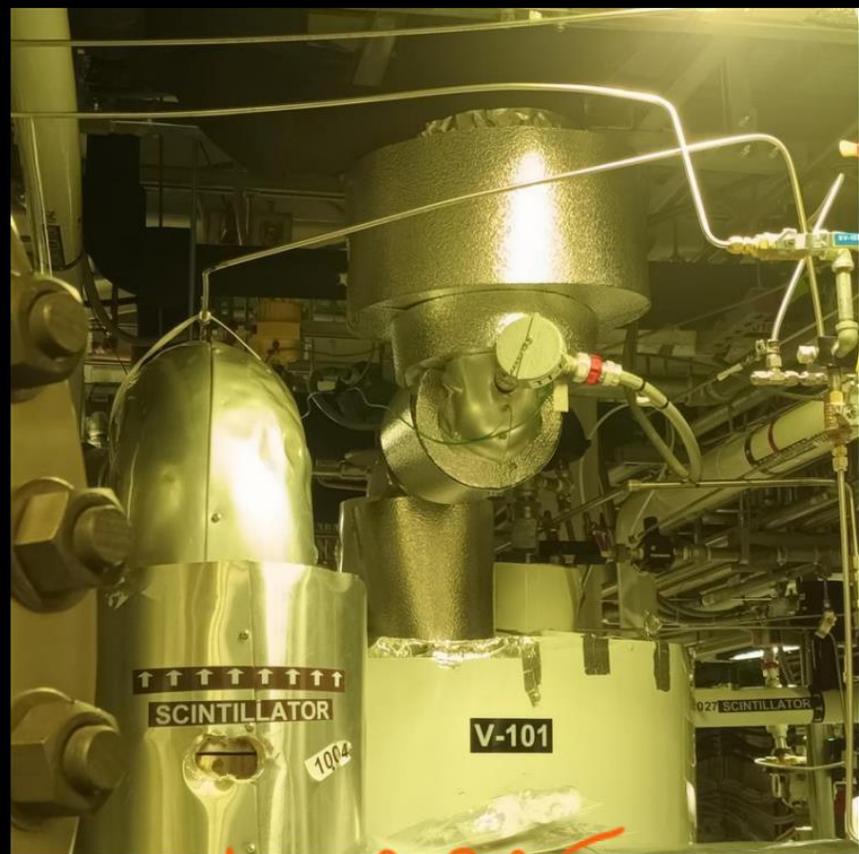
July 2024

March 2025

✓ HX installed and insulated

New heat exchanger installed

Scintillator plant re-commissioned

Cuts down start[up] time significantly

Running well – QA looks good

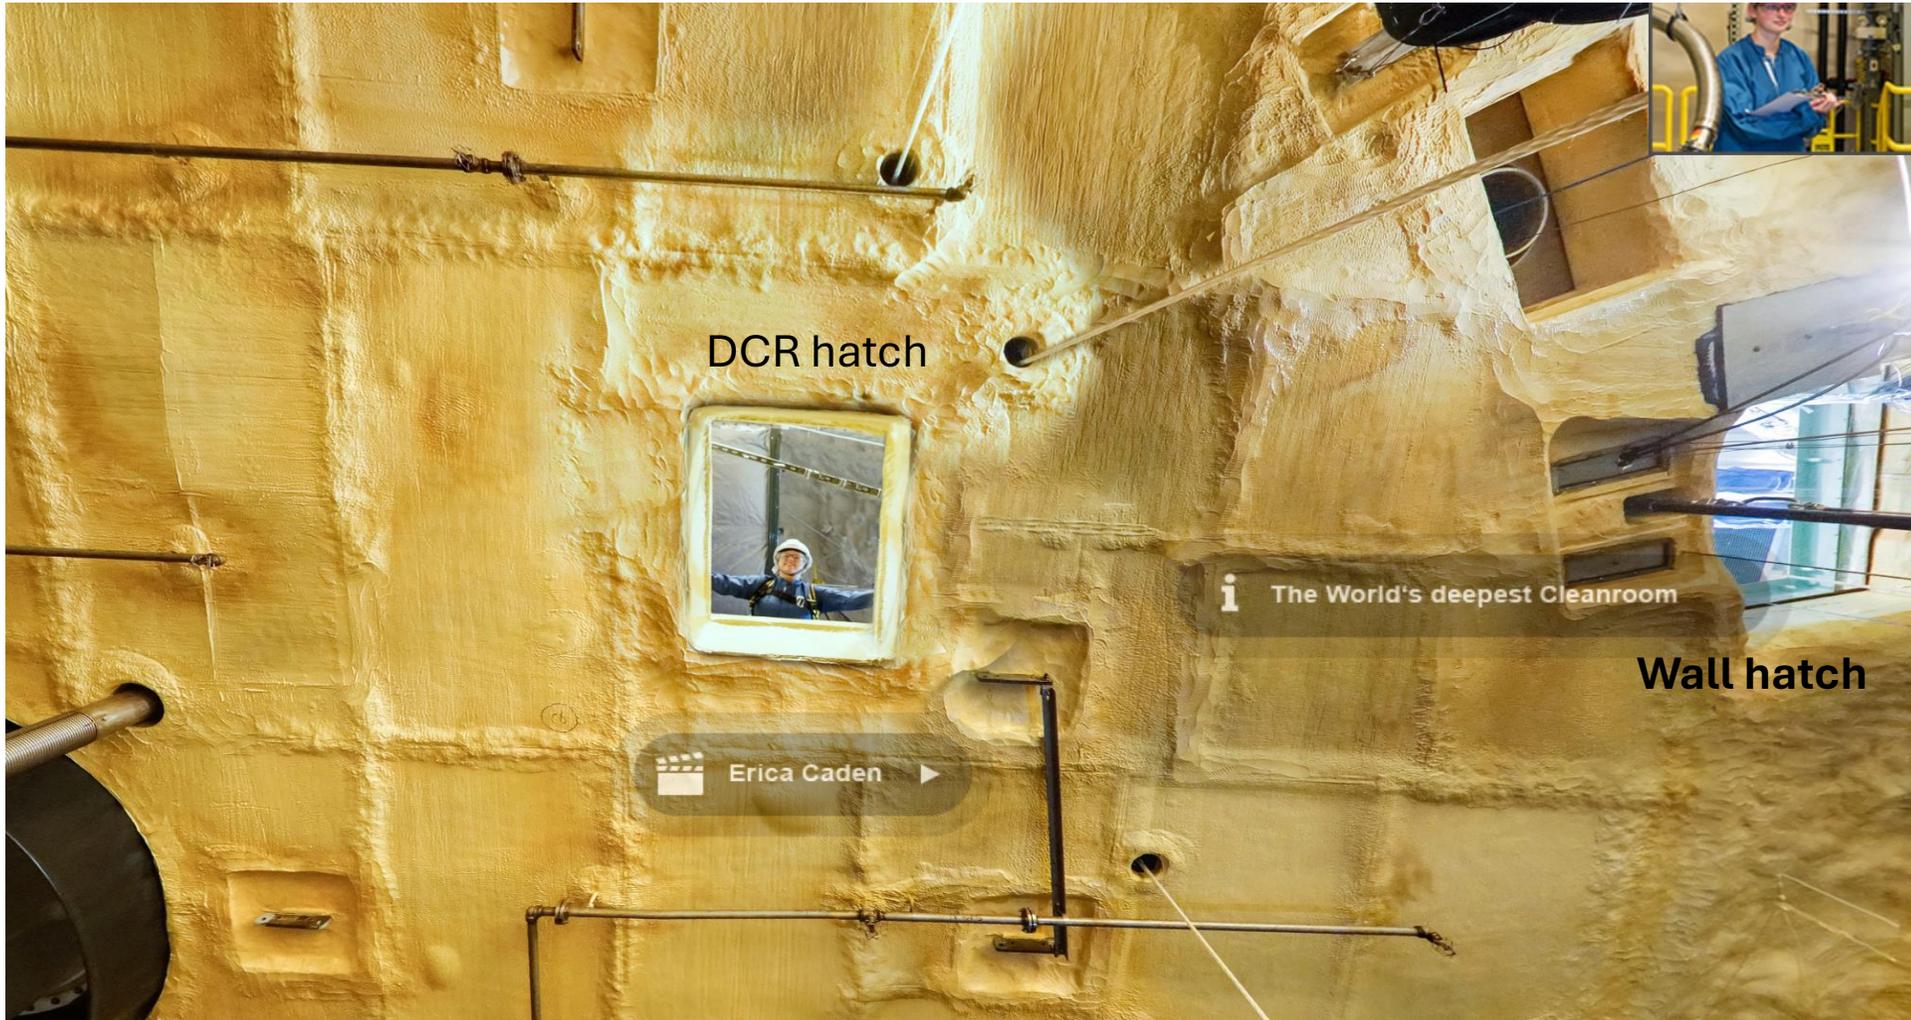
Looking up to two open hatches

Wall hatch is
Easiest access

DCR hatch is also
Fine – a little less
Convenient

At time both will be
Used.
