Engineering and Operations in the SNO+ Scintillator Plant: AV Draining

Cameron Van Der Zyl

SNO+ Cleanliness Monitoring Student → SNO+ Processing Plant Student

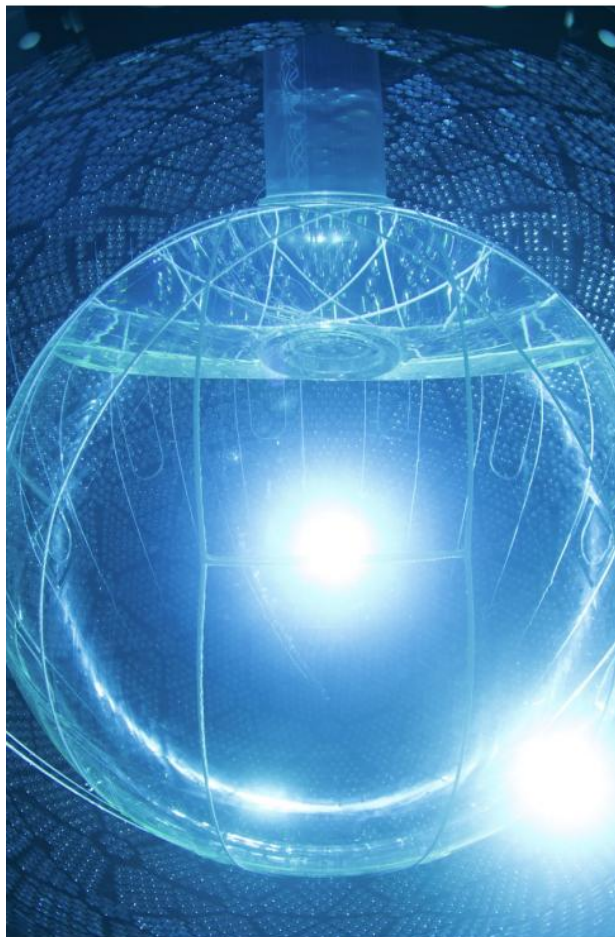
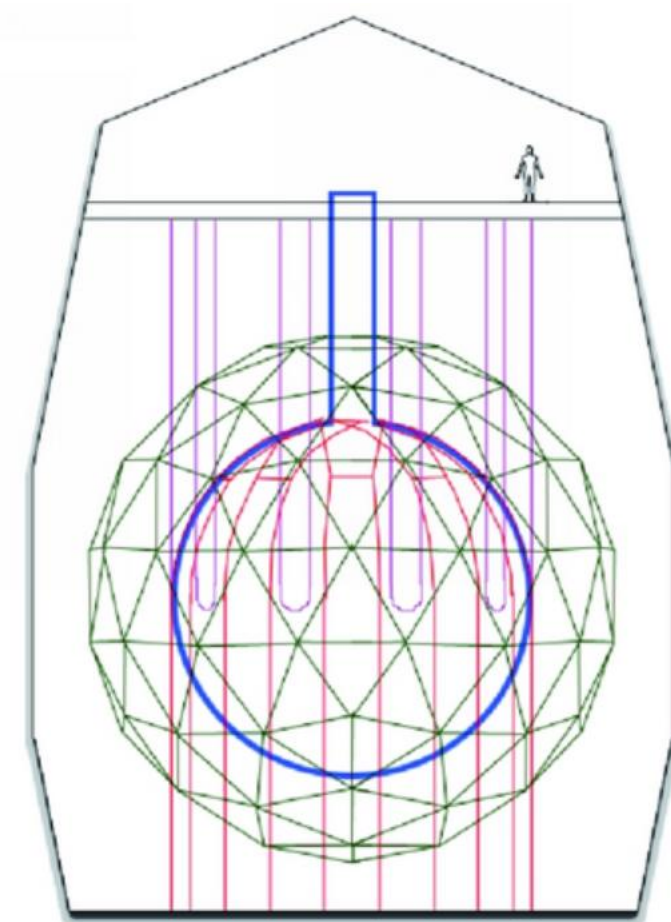
SNO+ Detector

Made up of many layers:

- Cavity (Filled with UPW)
- PMT Support Structure (PSUP)
- Acrylic Vessel
- Liquid Scintillator

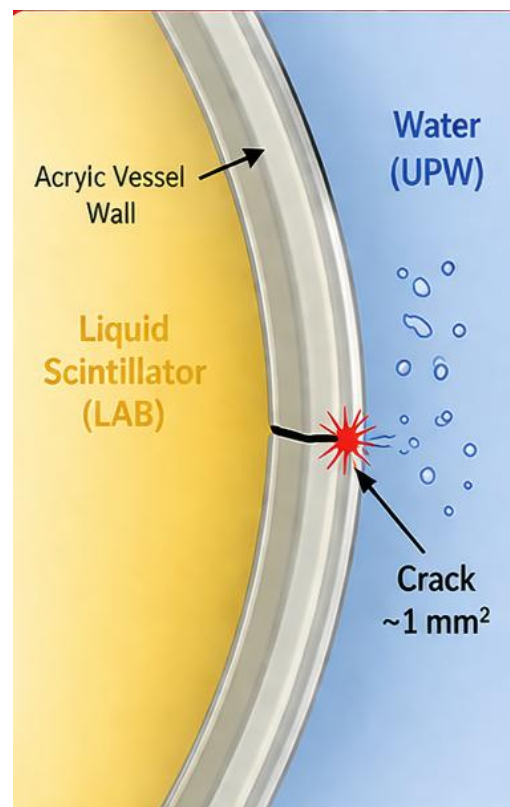
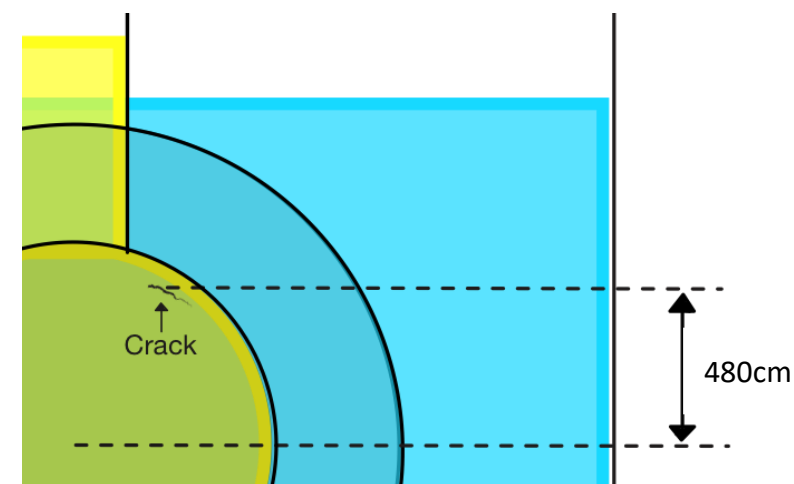
The Problem: AV Leak

- Small amounts of water leaking into AV
- Crack estimated to be $\sim 1\text{mm}^2$
- Using differential pressures; Crack located $\sim 480\text{cm}$ above equator
- To repair, draining of the AV and Cavity is required
- Acrylic is not easy to patch

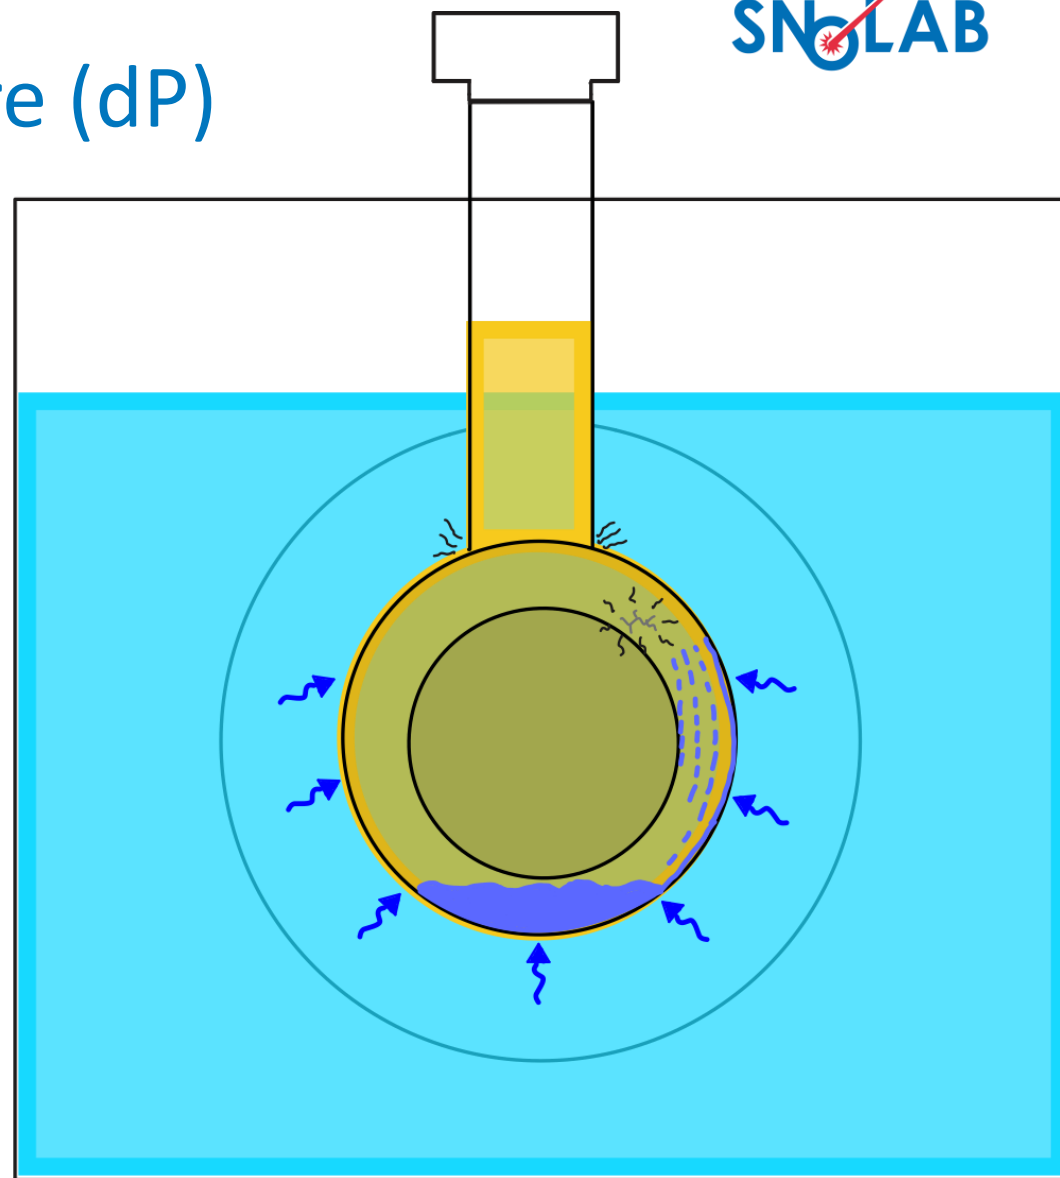
Critical Constraint: Differential Pressure (dP)

- Detector is made up of two fluid layers
- Required dP: 0dP at neck $\pm 5 \text{ inH}_2\text{O}$
- Current Operational dP: $-10 \text{ inH}_2\text{O}$ to $-1.5 \text{ inH}_2\text{O}$
- Must keep:
 - AV safe (avoid stress on crack and neck)
 - LAB out of cavity
- Scintillator Density @ 12°C $\sim 869.0 \text{ kg/m}^3$
- UPW Density @ 12°C $\sim 999.45 \text{ kg/m}^3$
- The cavity level is $\sim 3\text{ft}$ lower than the AV when full giving a dP = 0
- As level is lowered in cavity and AV, smaller changes in level make bigger changes to dP

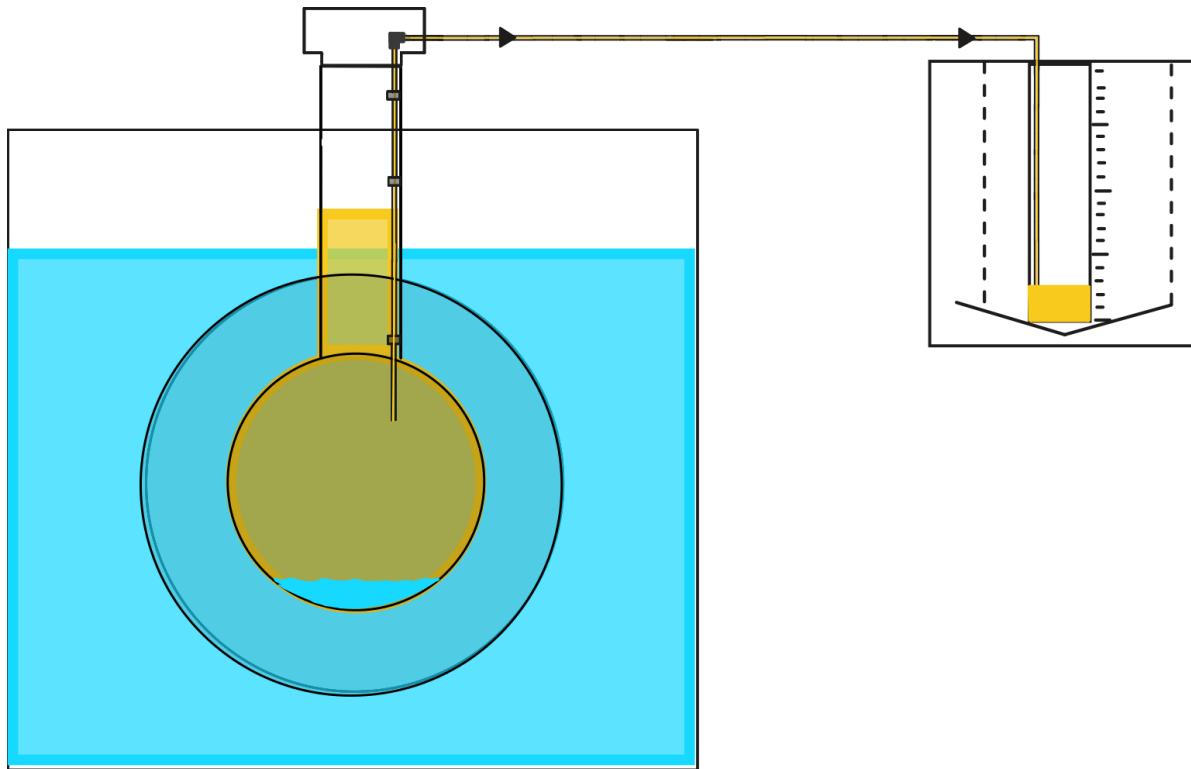
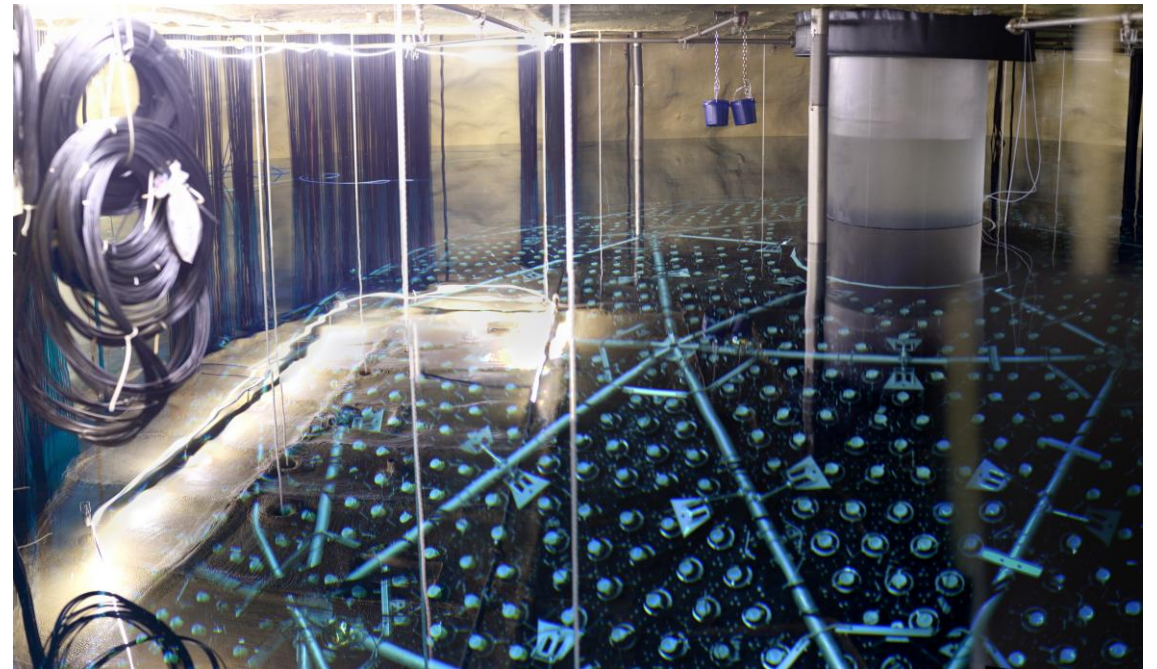
Initially

- Drain from the AV to 60 tonne tanks
- Flow path is direct
- Large distance to travel
- Very simple, no processes

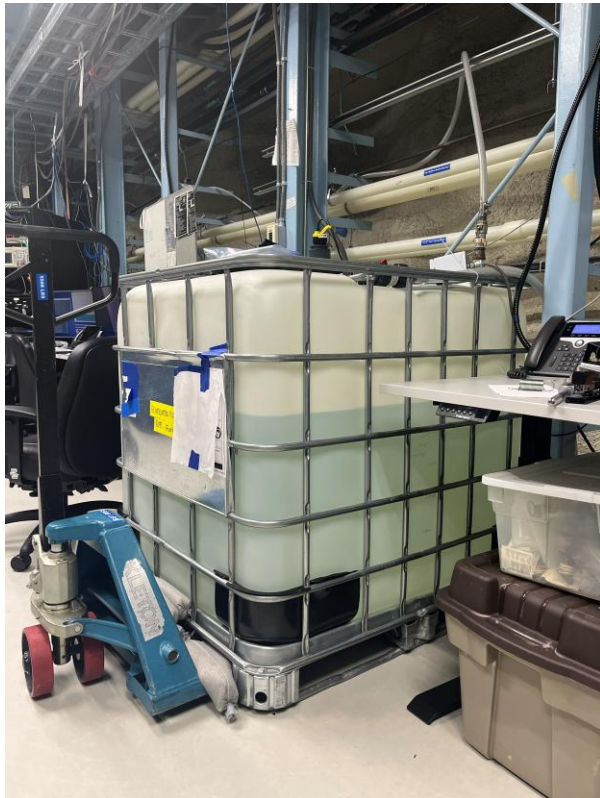
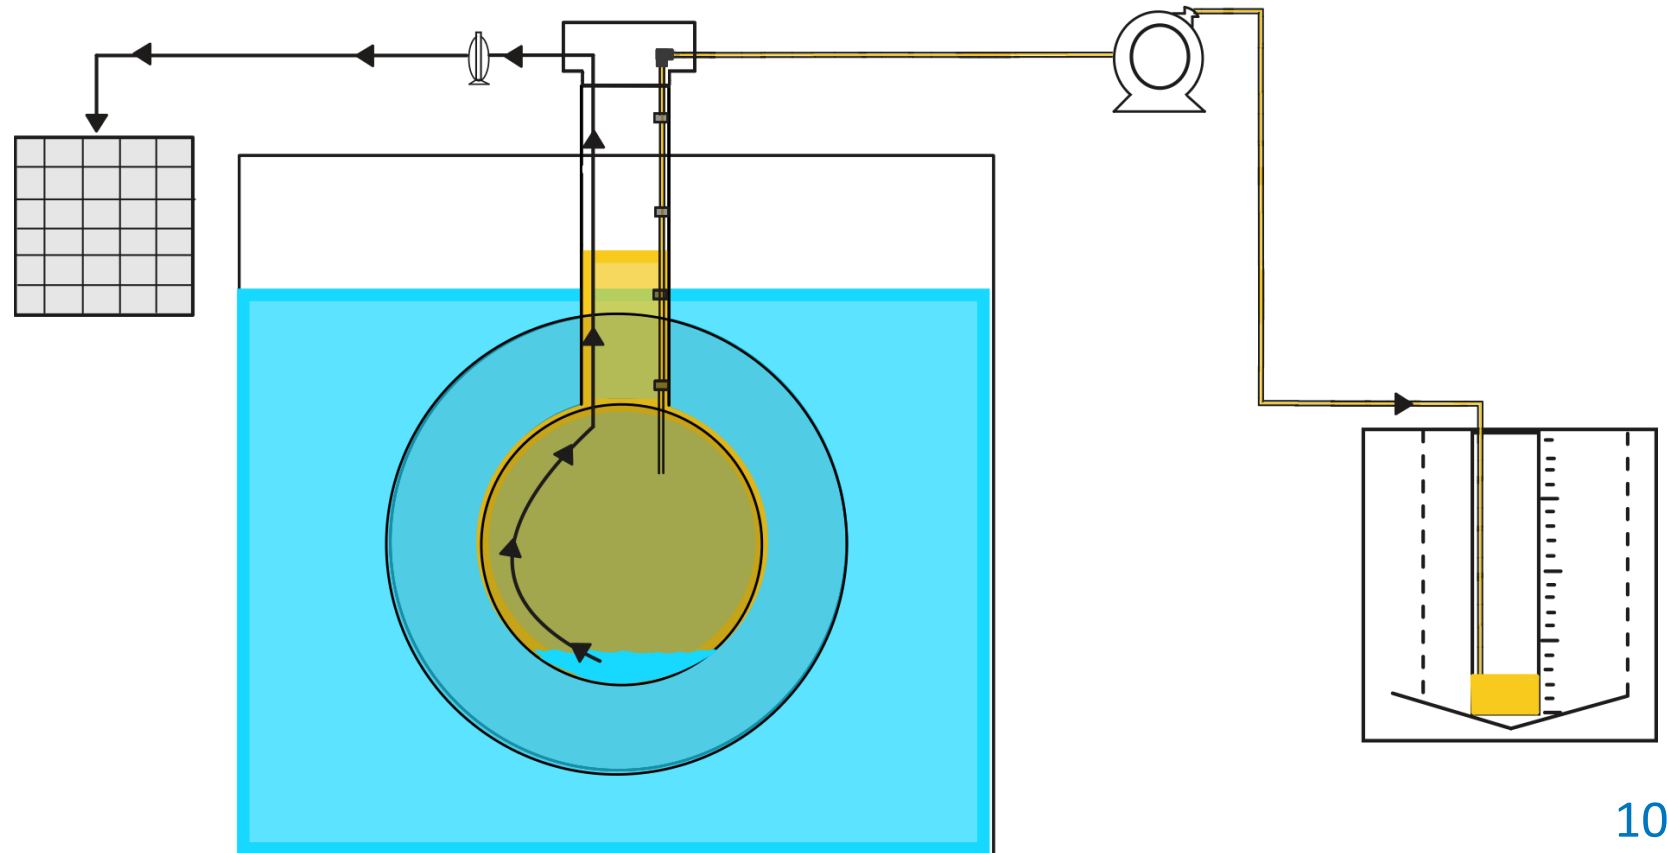
Initially

- Use a bubbler pump & line to pull from bottom
- Pump to a tote in SNO+ control room
- Monitor potential scintillator uptake

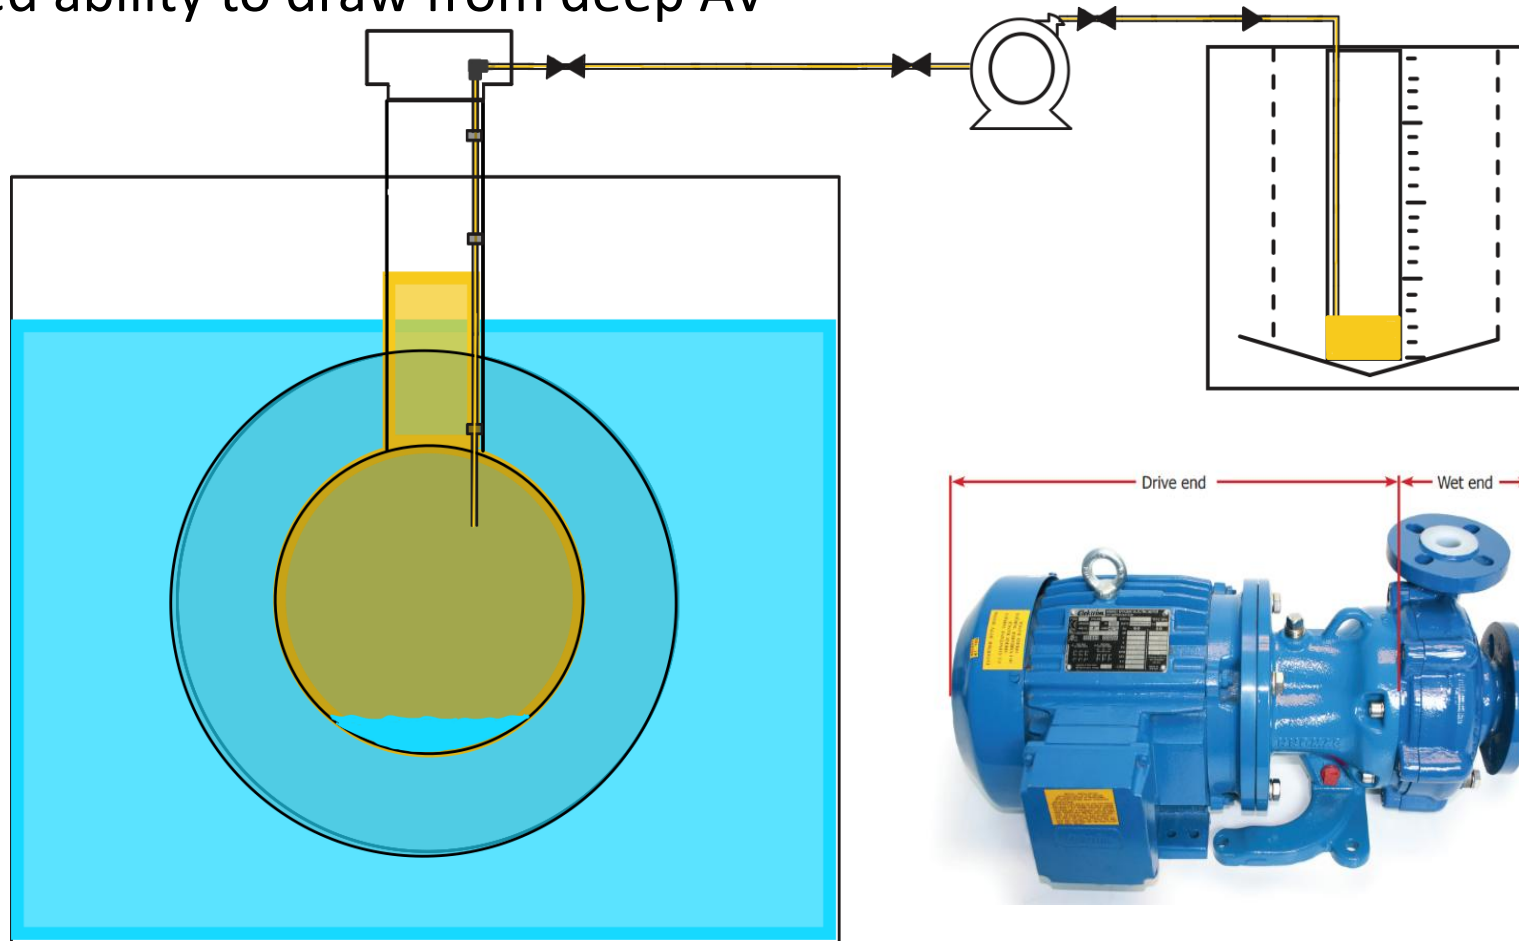
Initial

- Centrifugal pump in line
- Cannot pull suction → requires flooded inlet
- Limited ability to draw from deep AV

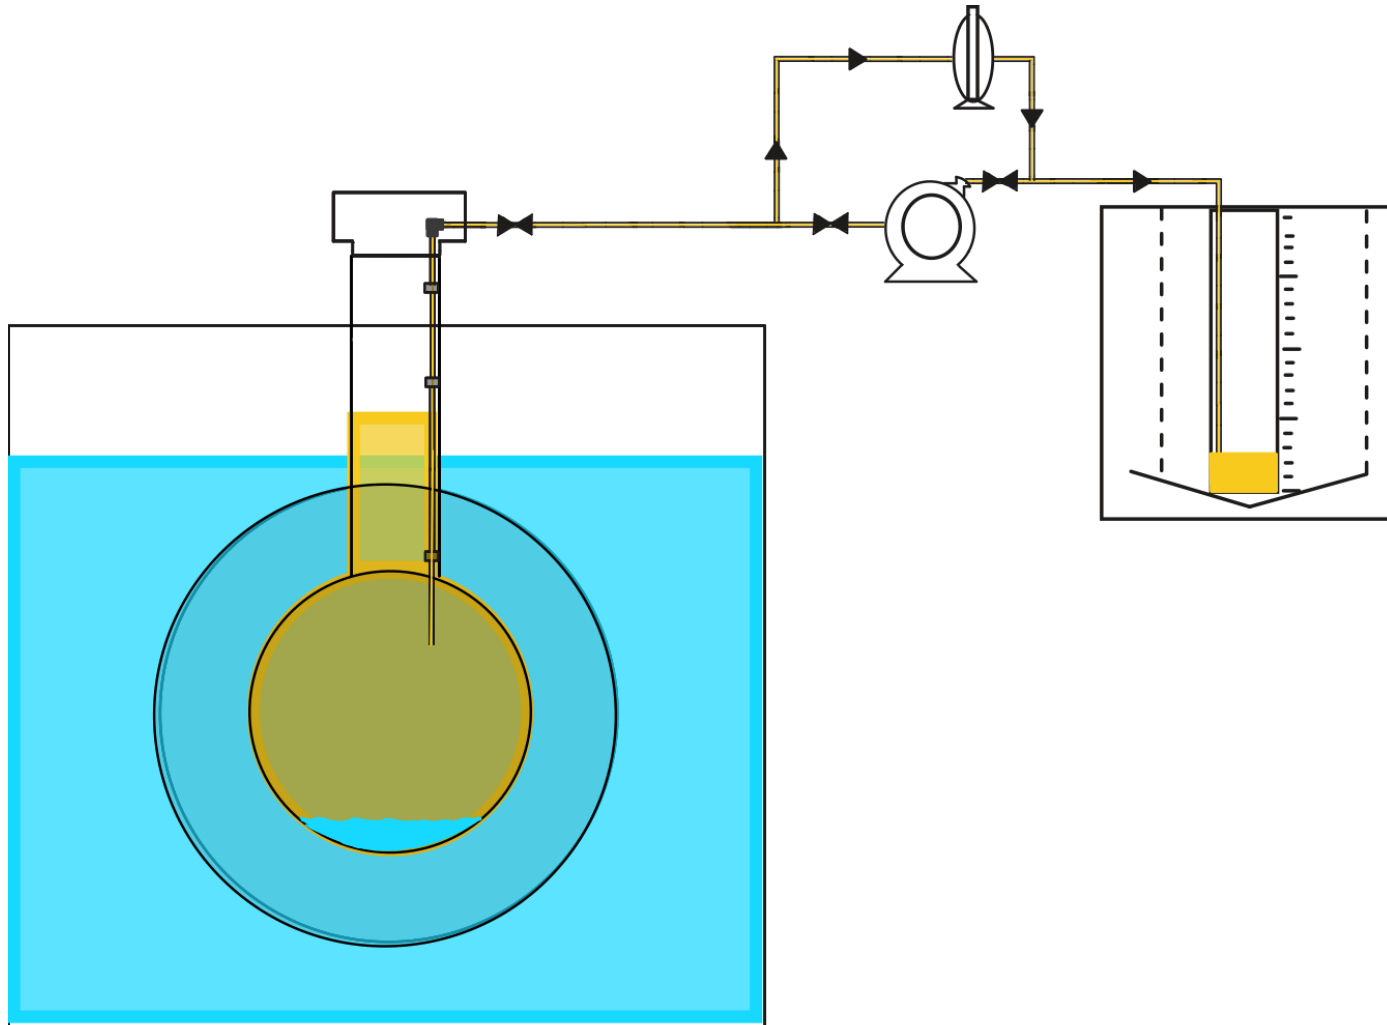
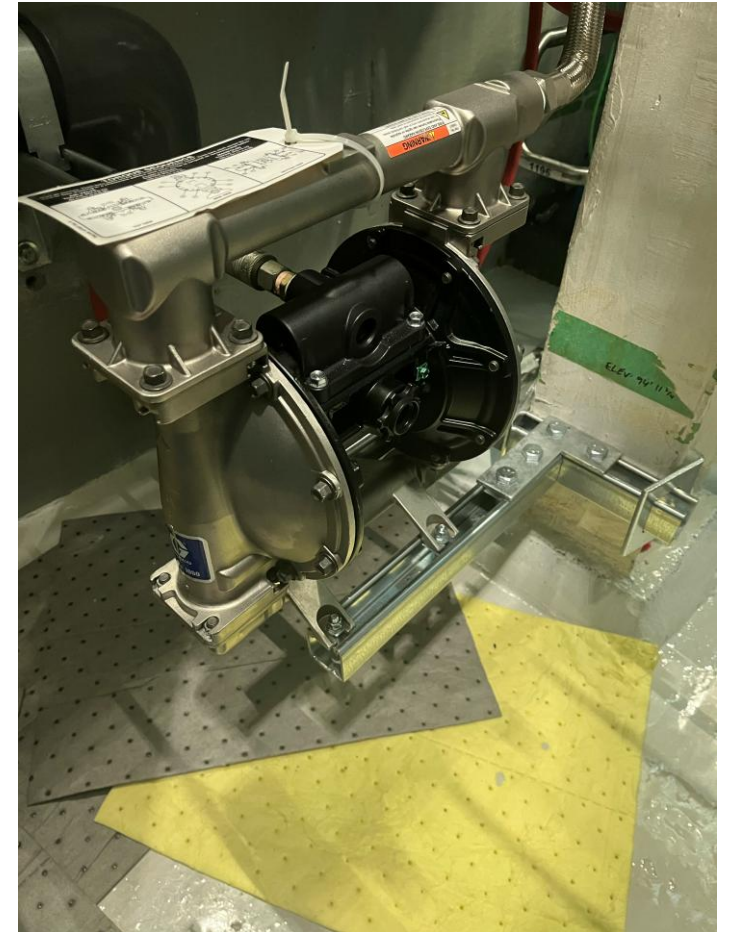
Initially

- Addition of a Diaphragm Pump
- Can pull suction (28ft head) → required for deeper draining

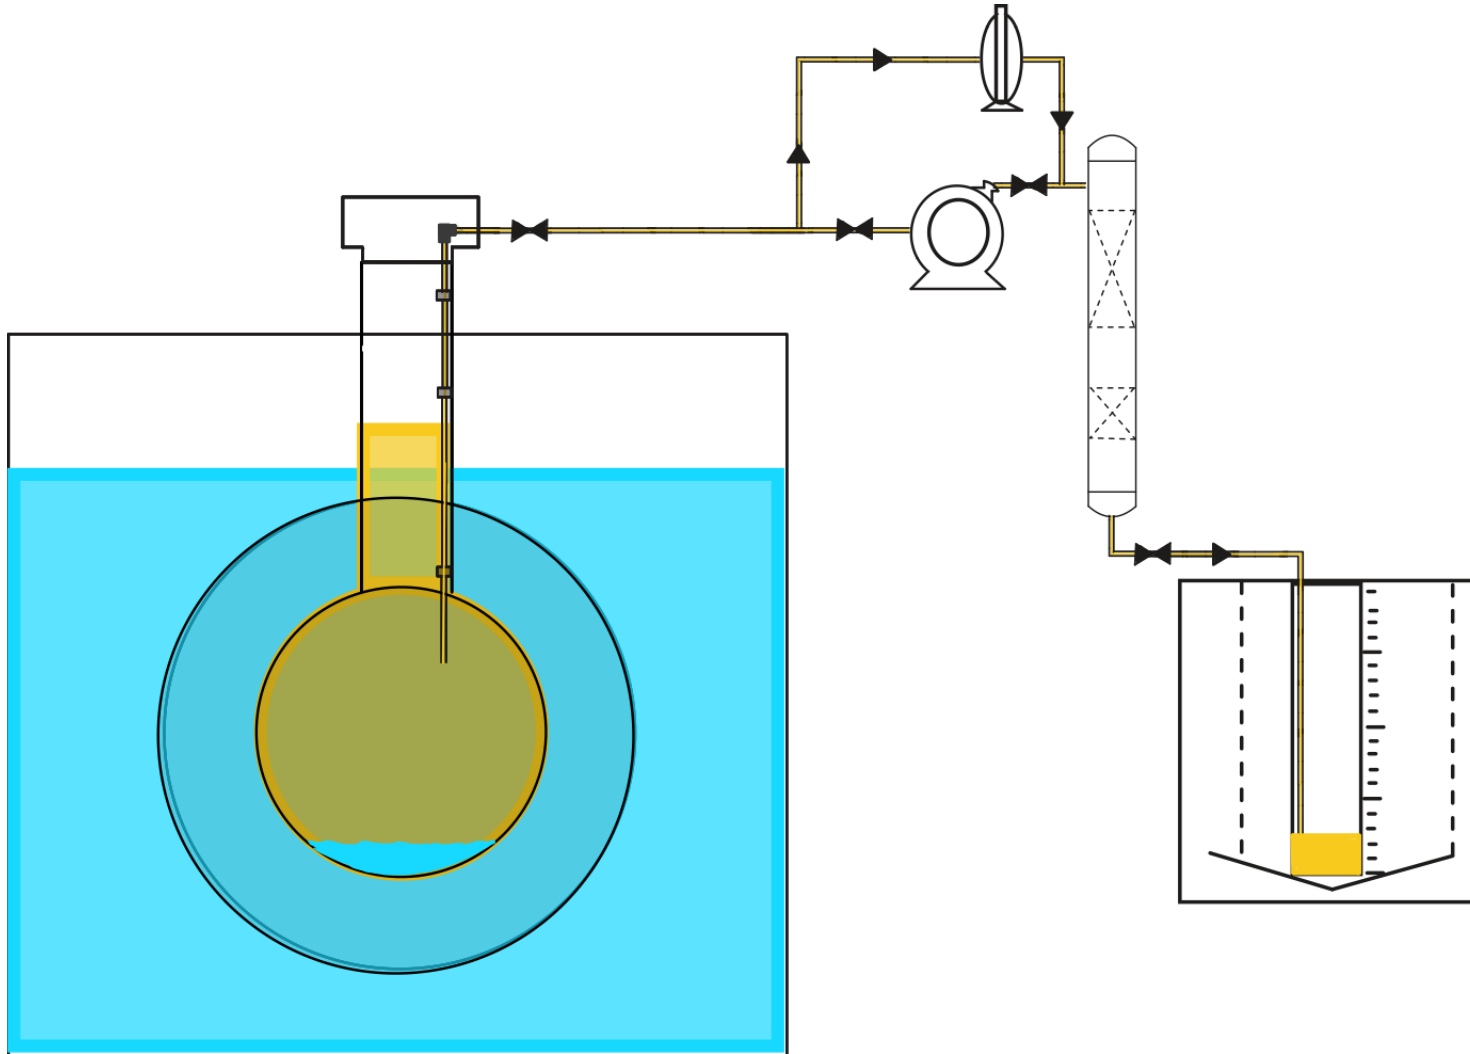
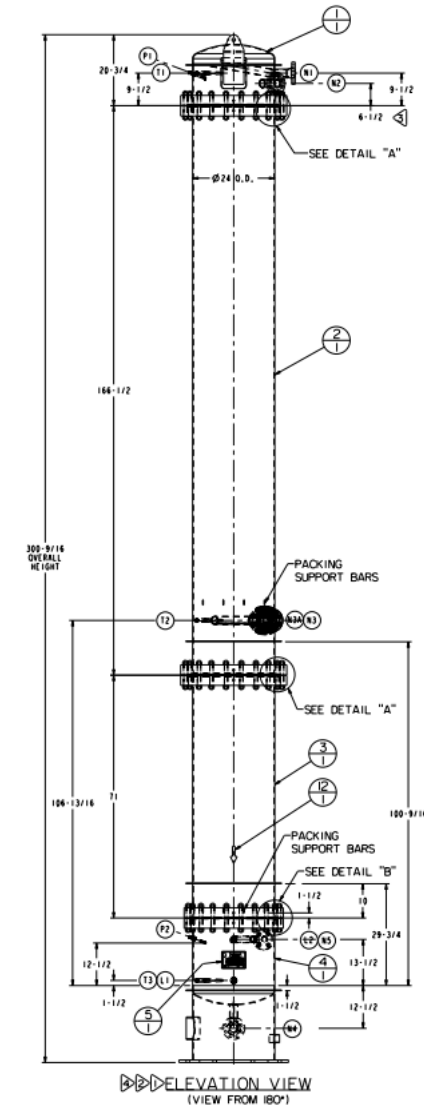
Current

- Use a stripping column to assist pump
- Draws vacuum on line for more net positive suction lift

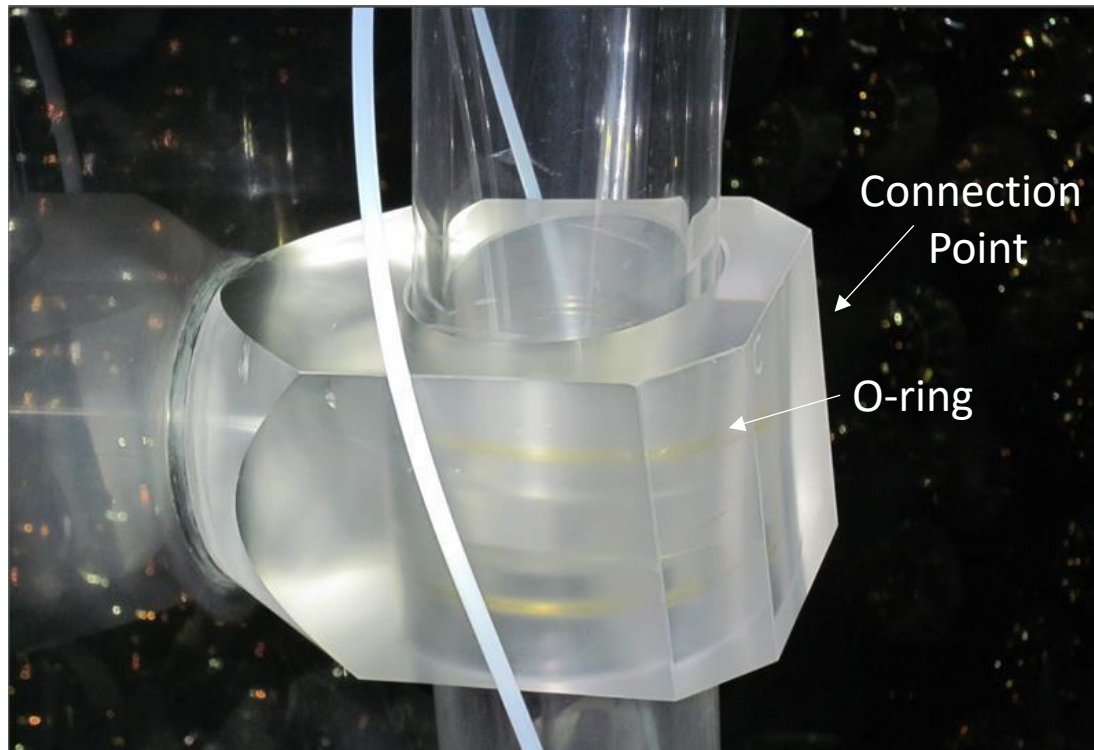
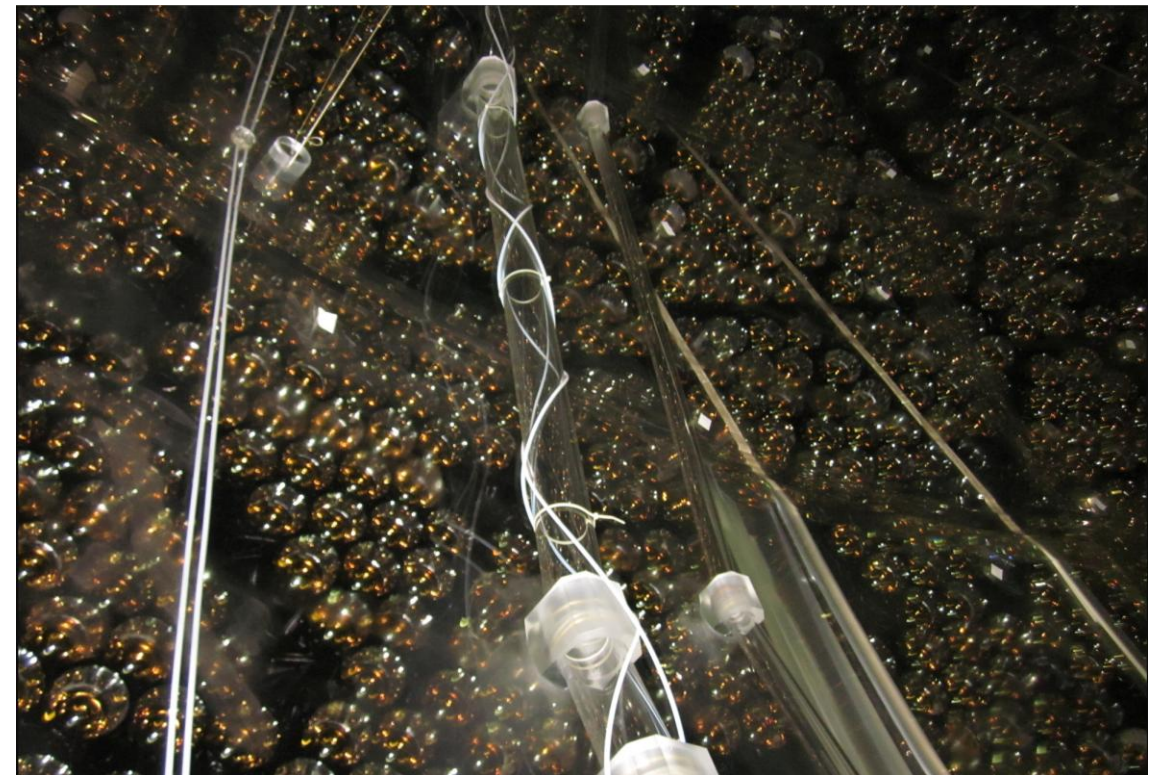
Current

- Using an Acrylic Pipe
- Made up of many small sections with connection points
- Sealed using O-rings → incorrect sizing leads to leaks at joints
- Generally unreliable

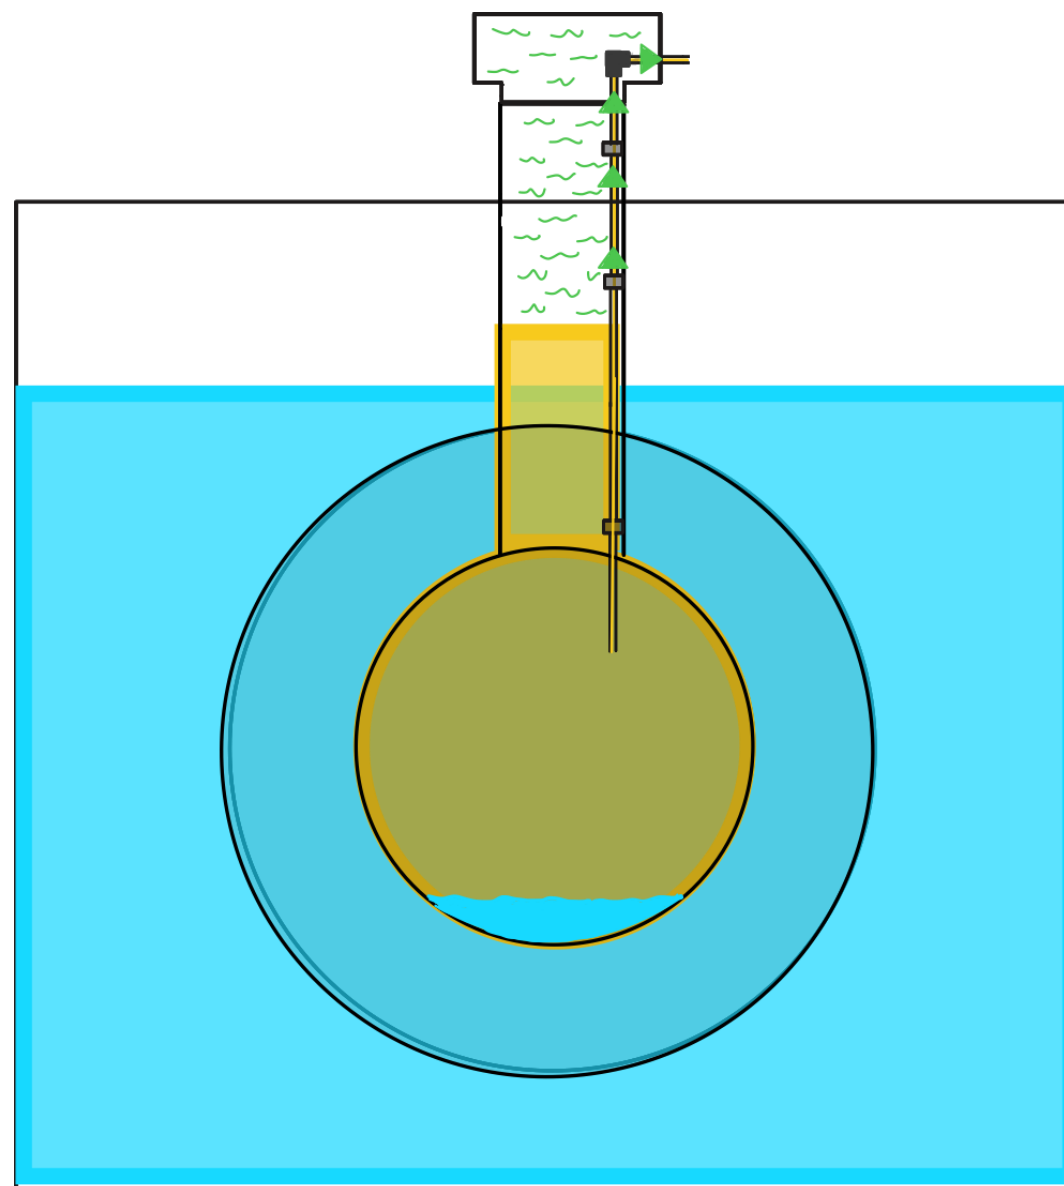
Gas Ingress Problem (N_2)

- When AV level drops below leak \rightarrow gas enters system
- Pump draws N_2 instead of liquid
- Causes
 - Loss of pump prime
 - Reduced flow
 - Plant instability

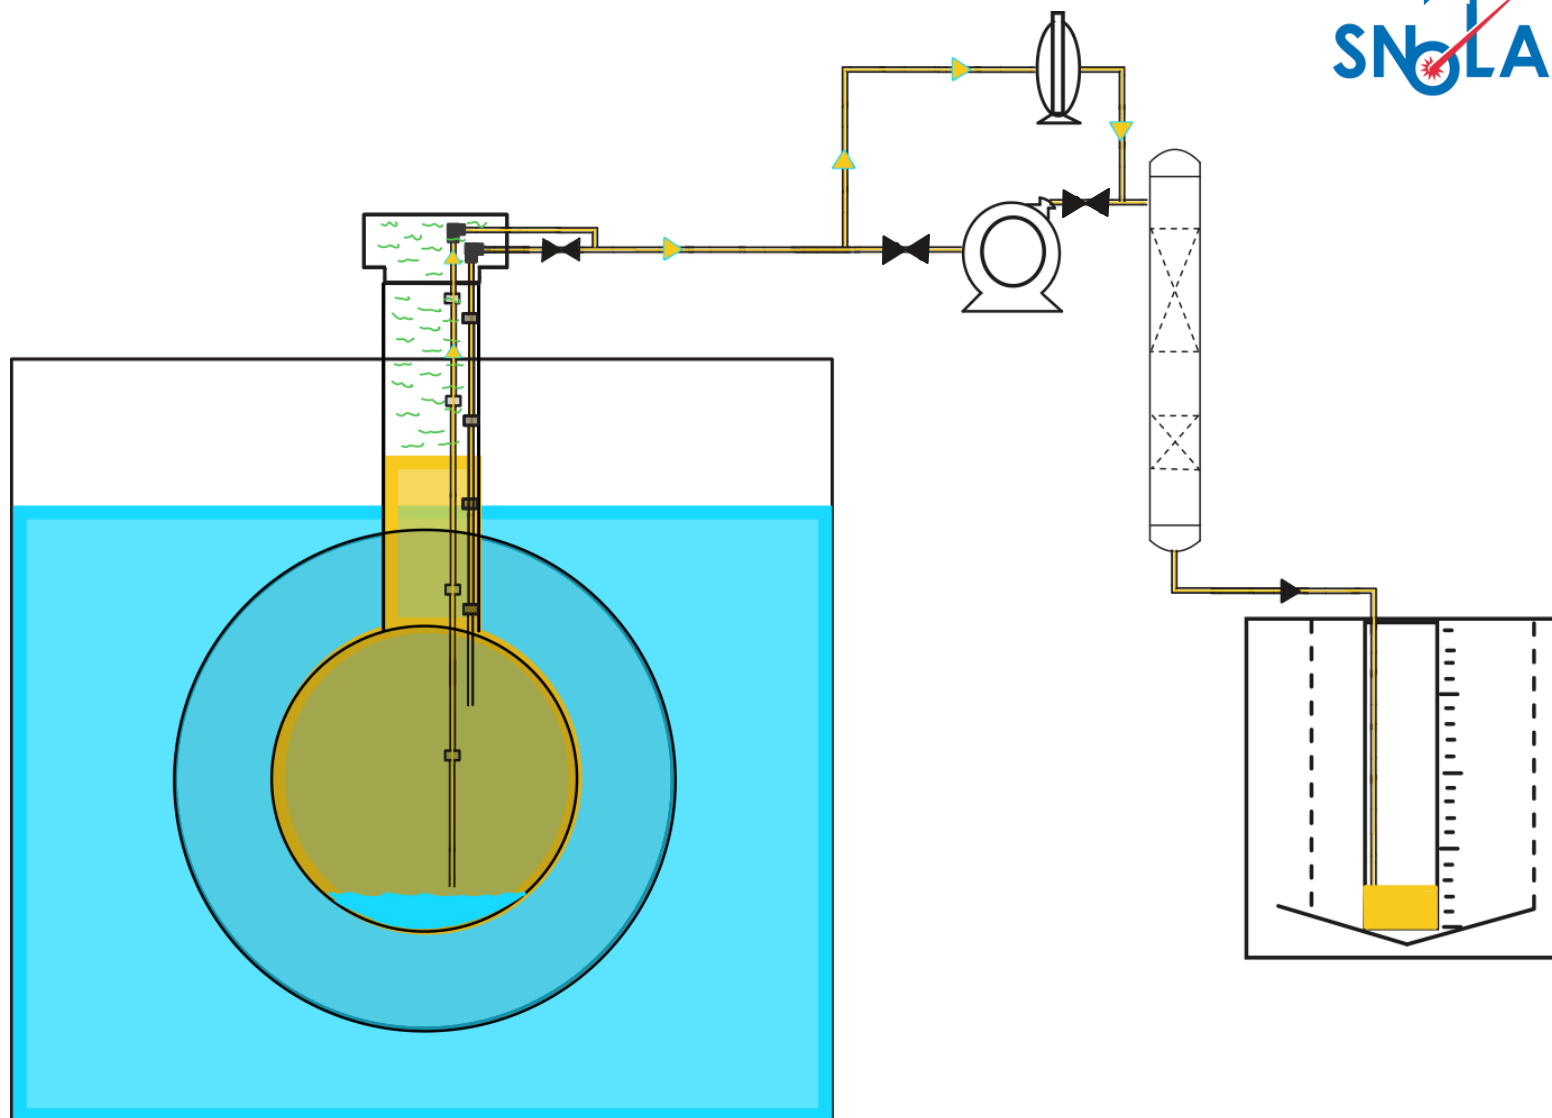
Current

- Switched to bottom line to avoid gas intake
- Causes intake of water
- May be pulling through connection points

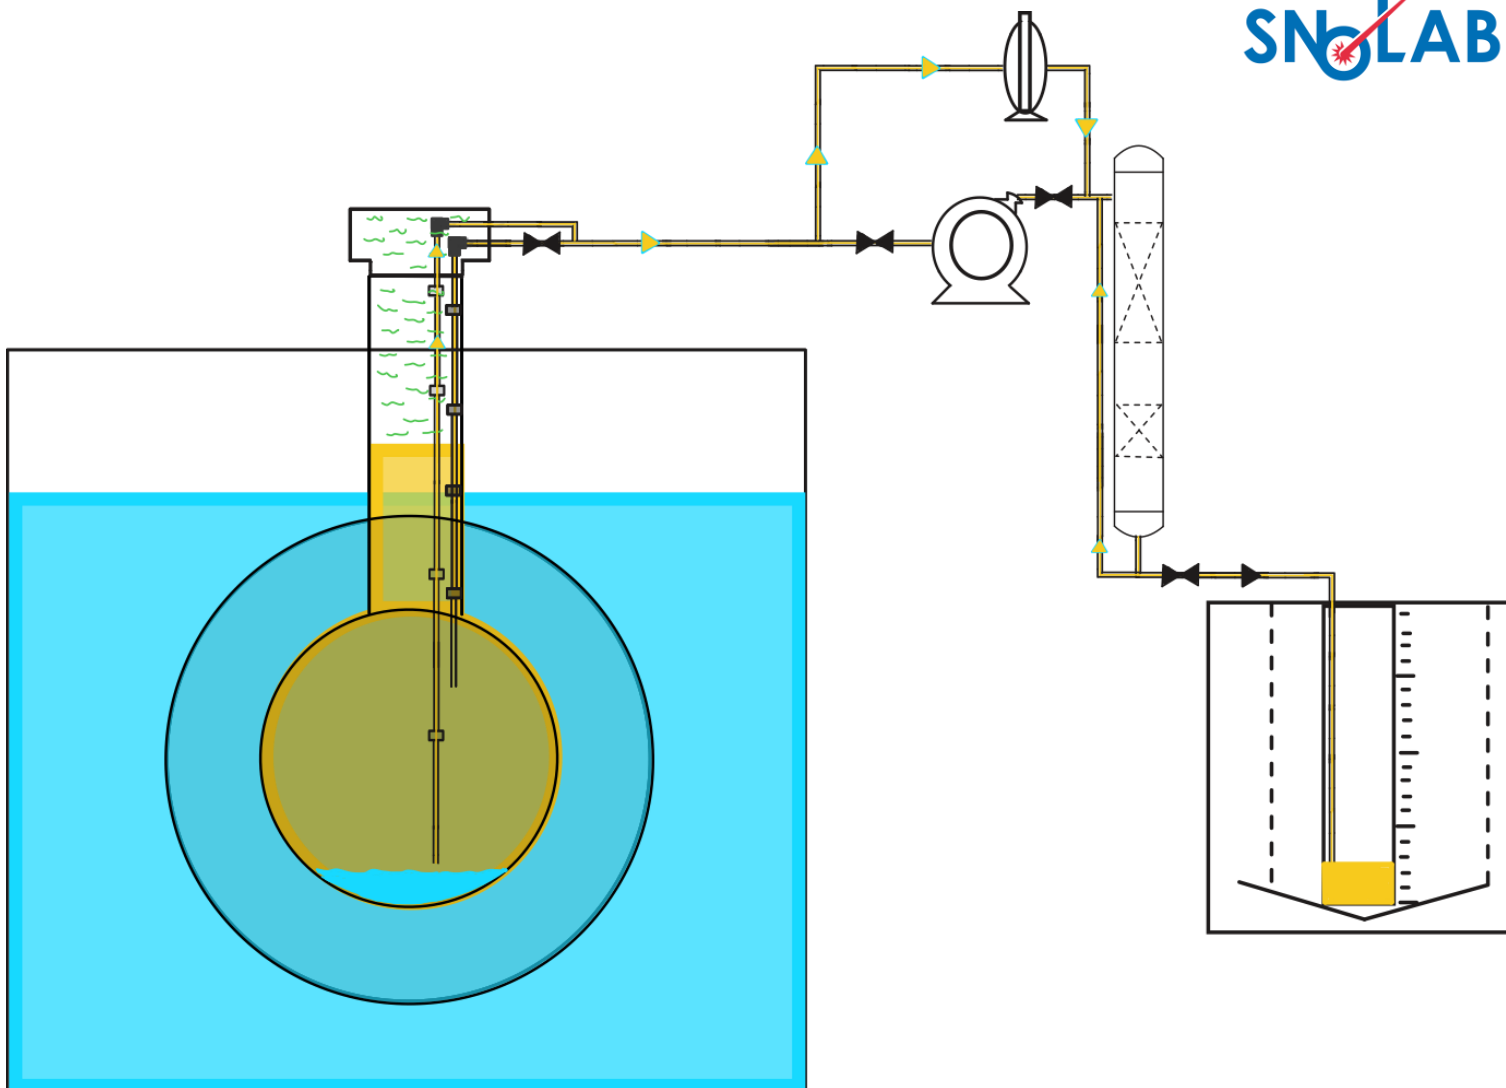
Current

- Start using stripping column with heat
- Running batch stripping
- Unknown amount of water with scintillator

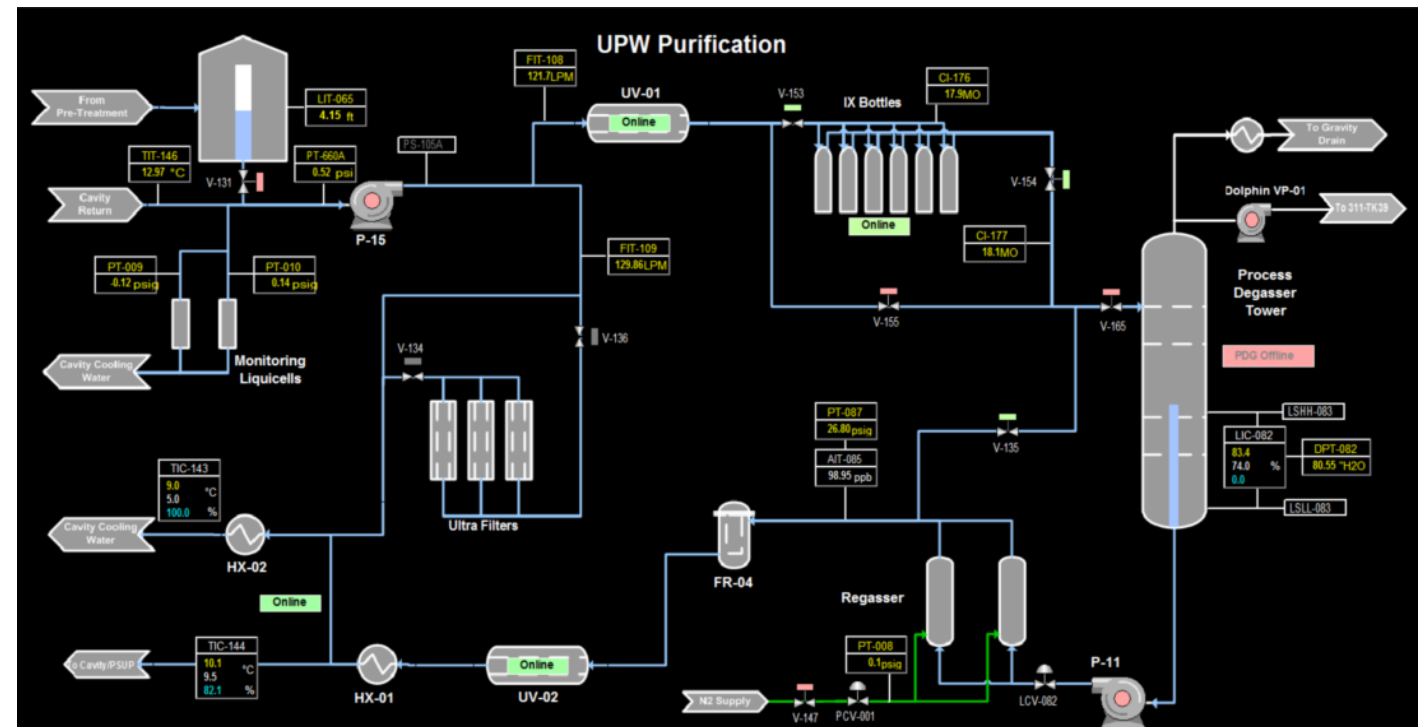
UPW Plant

- Continuous draining
- During normal operations, flow is split between recirculation and cooling

- During draining, recirculation flow is altered
- Flow can go straight to drain

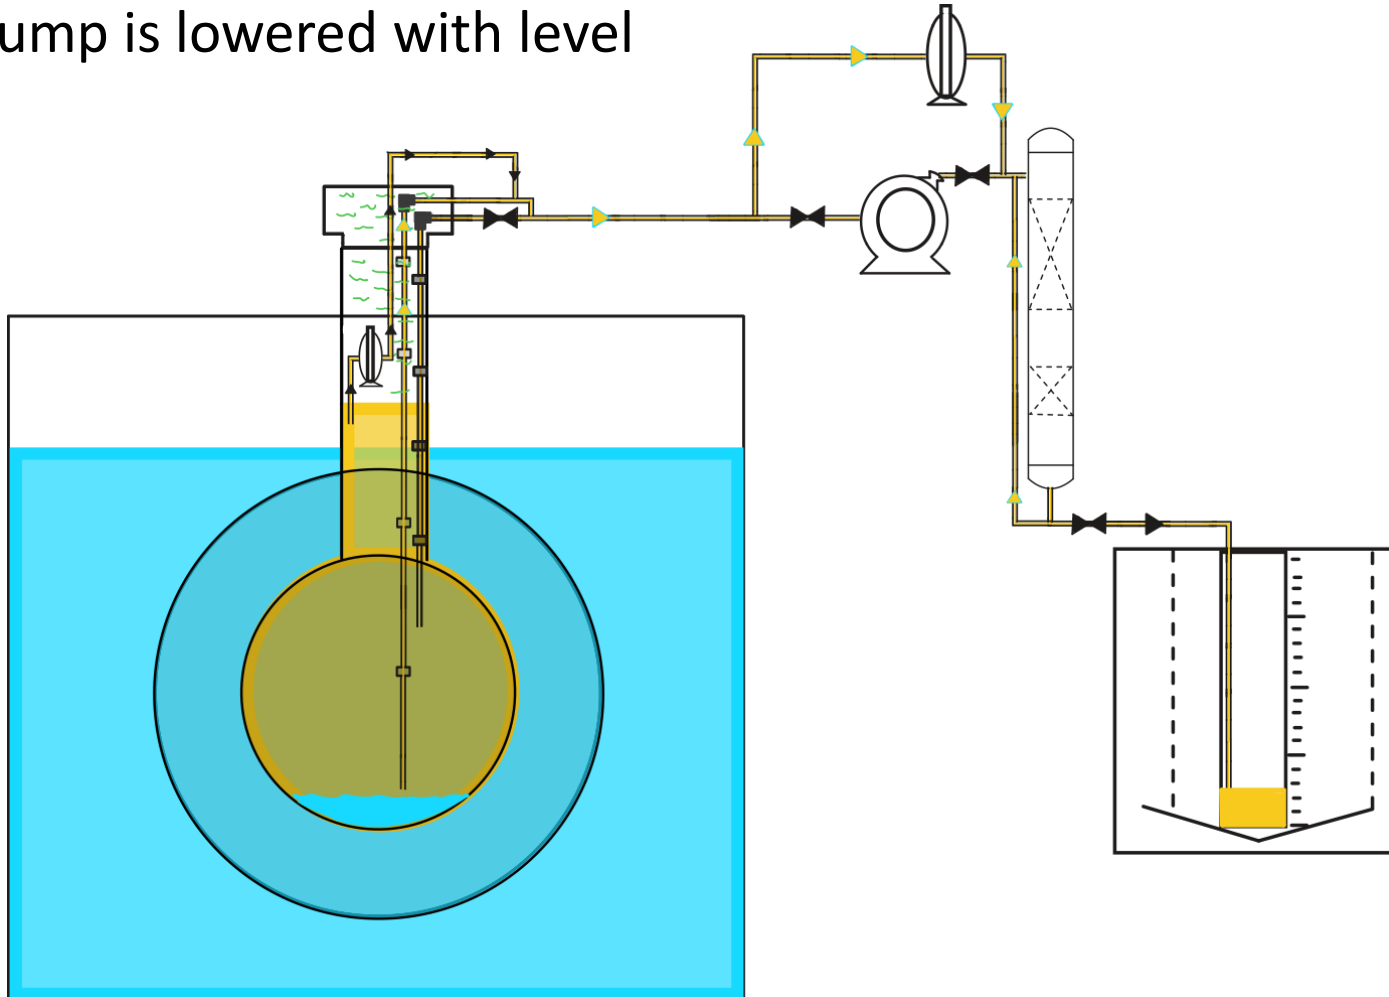
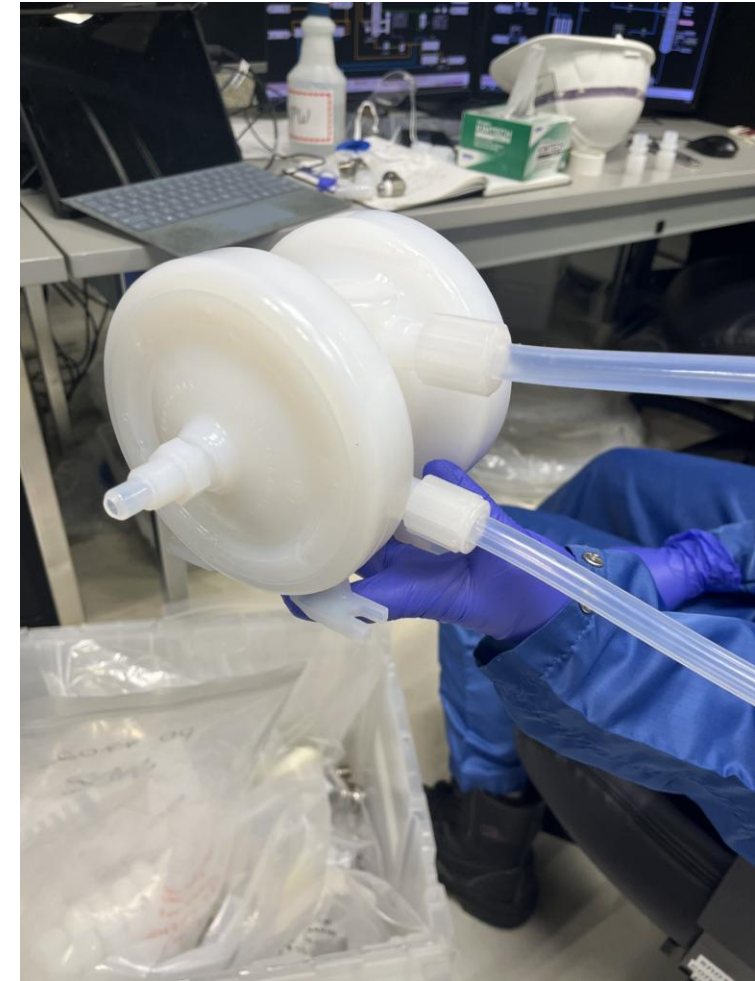
Future

- Increasing suction requirement as level decreases
- Pump is lowered with level
