# The NEWS-G Experiment

SEF 2024-07-31

Philippe Gros (Queen's U)  
for the NEWS-G collaboration

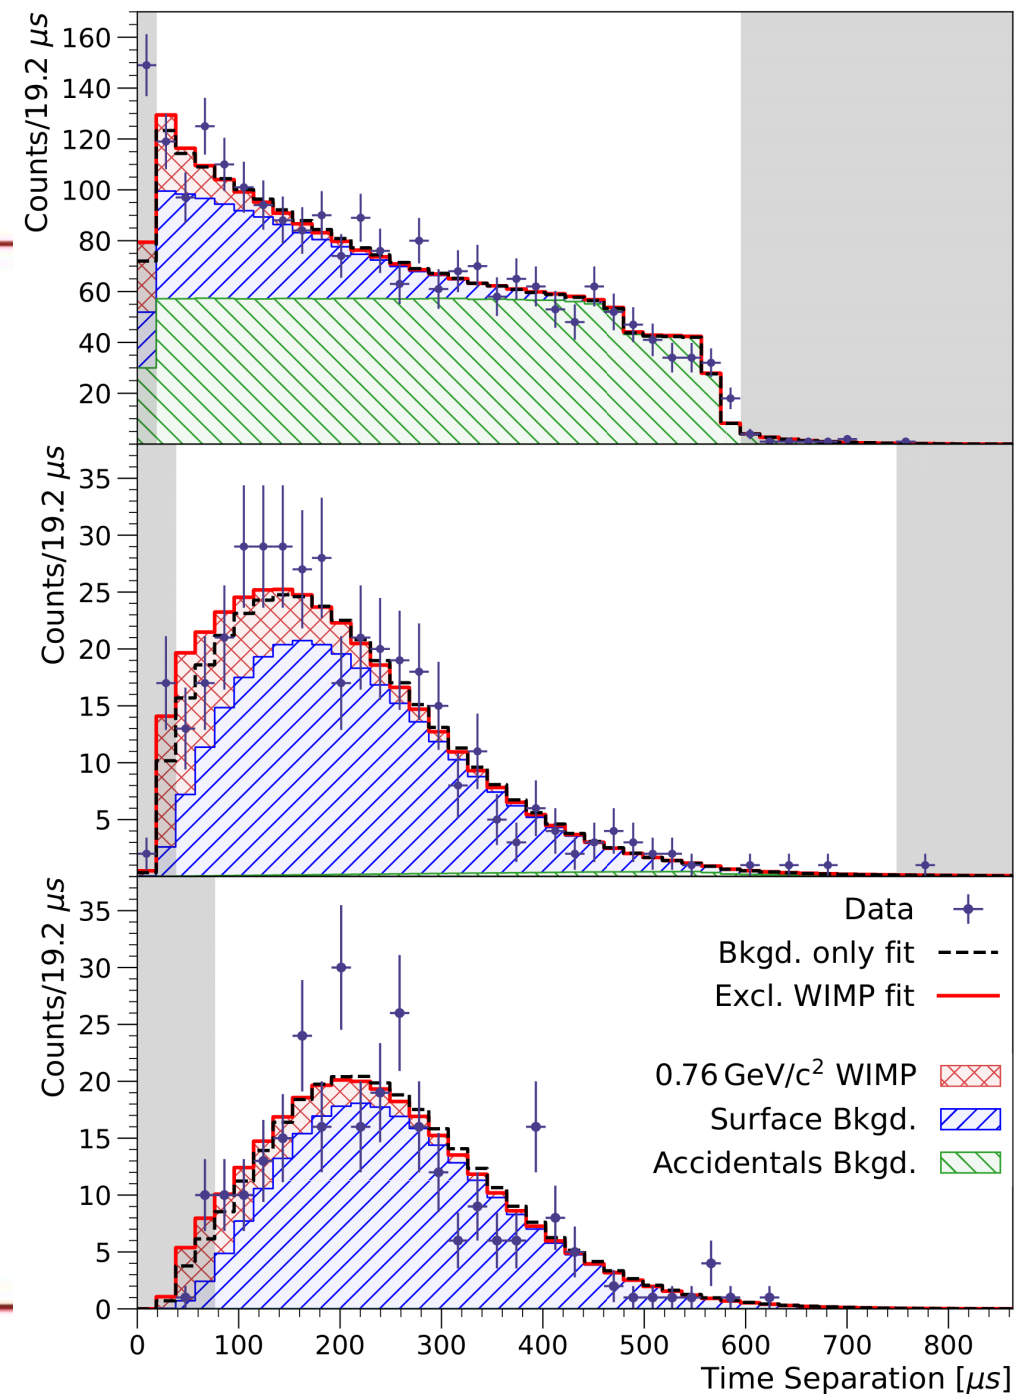
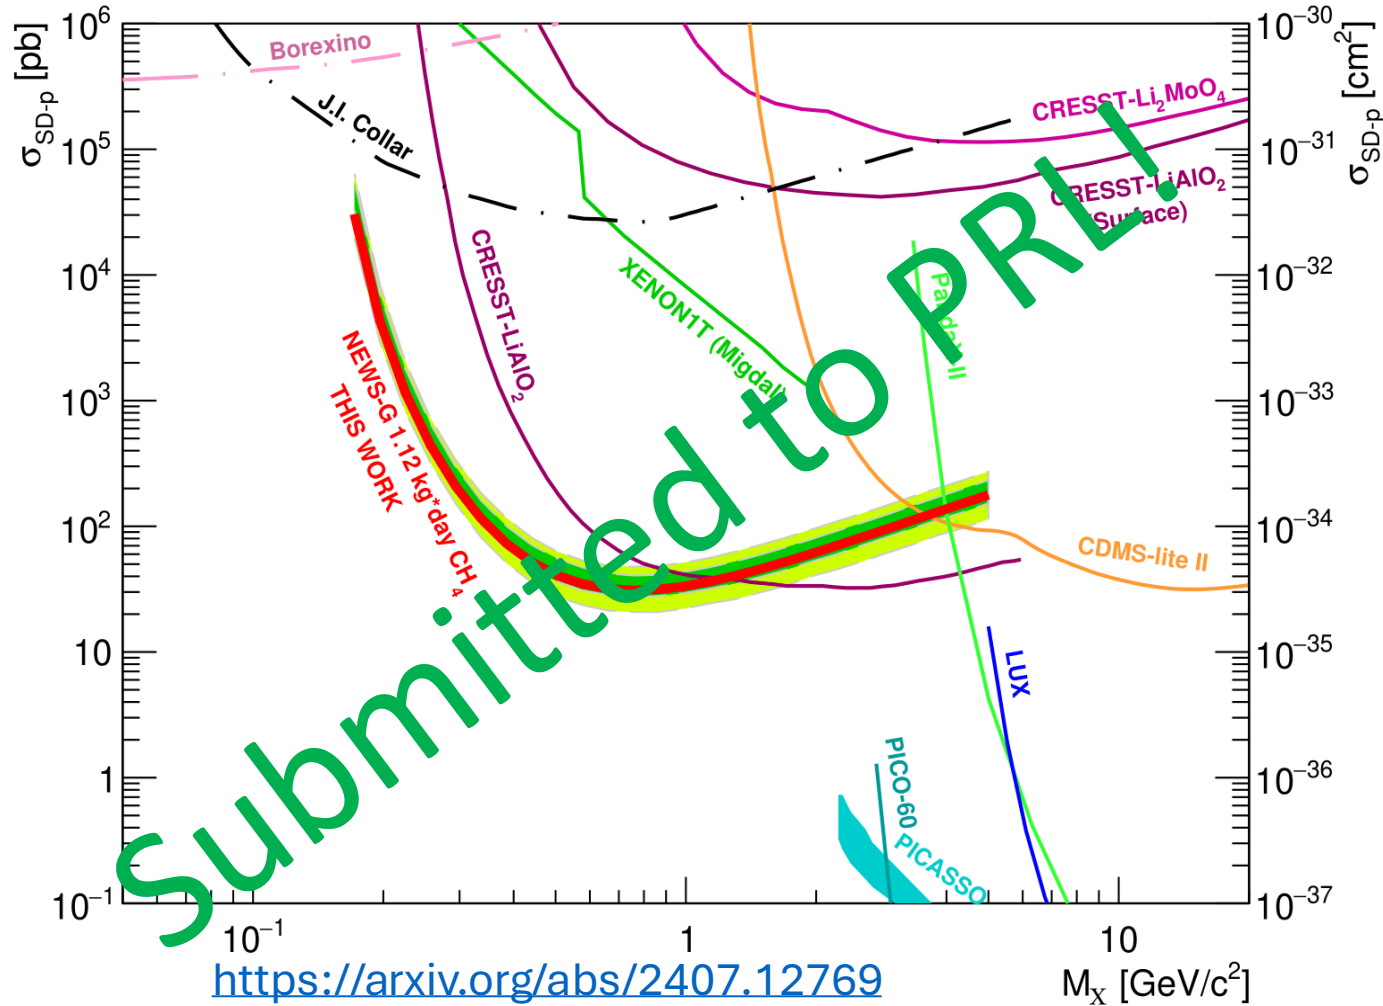
- Data taken in fall 2019 with temporary shield at LSM
- Gas: 135mbar pure CH<sub>4</sub>
- Electron counting possible
- Negative induced pulses of 2nd channel allows rejection of electronics noise
- Time separation between electrons allows surface noise rejection
- 30% of test data, 70% blinded

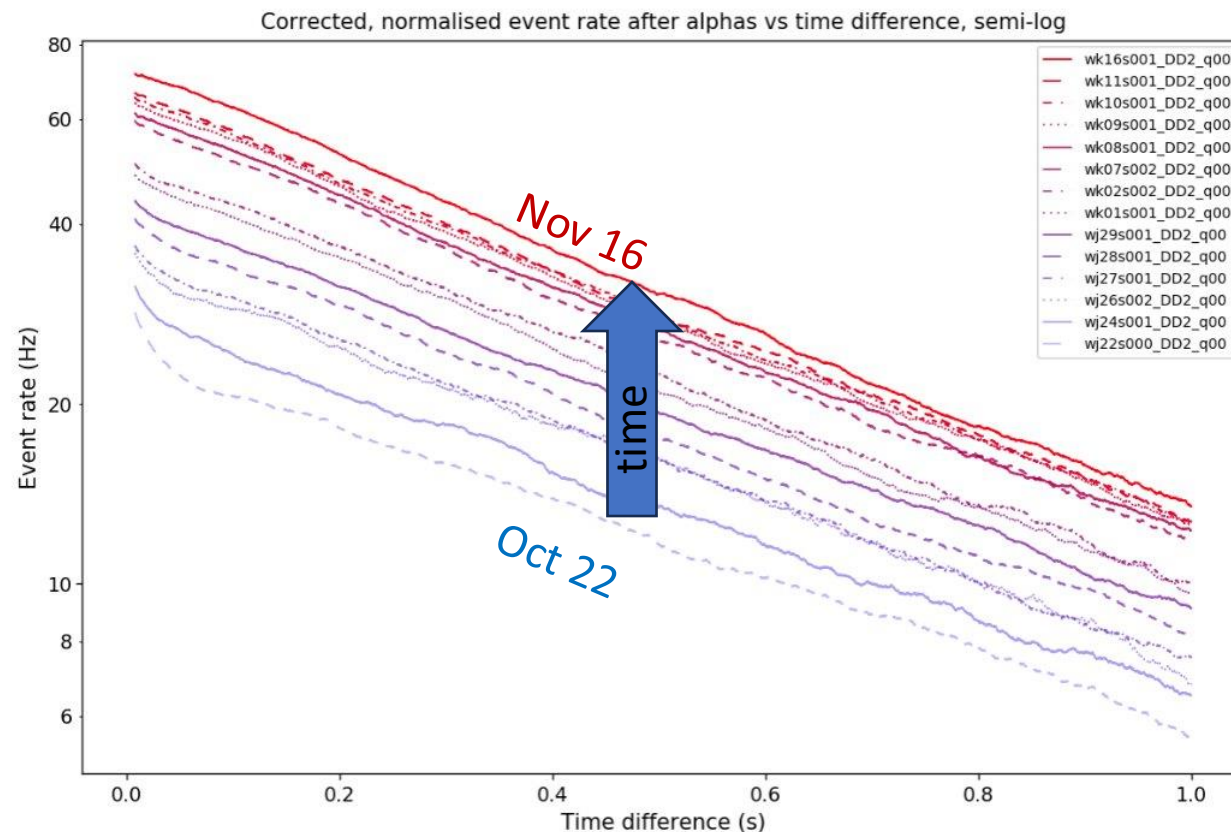
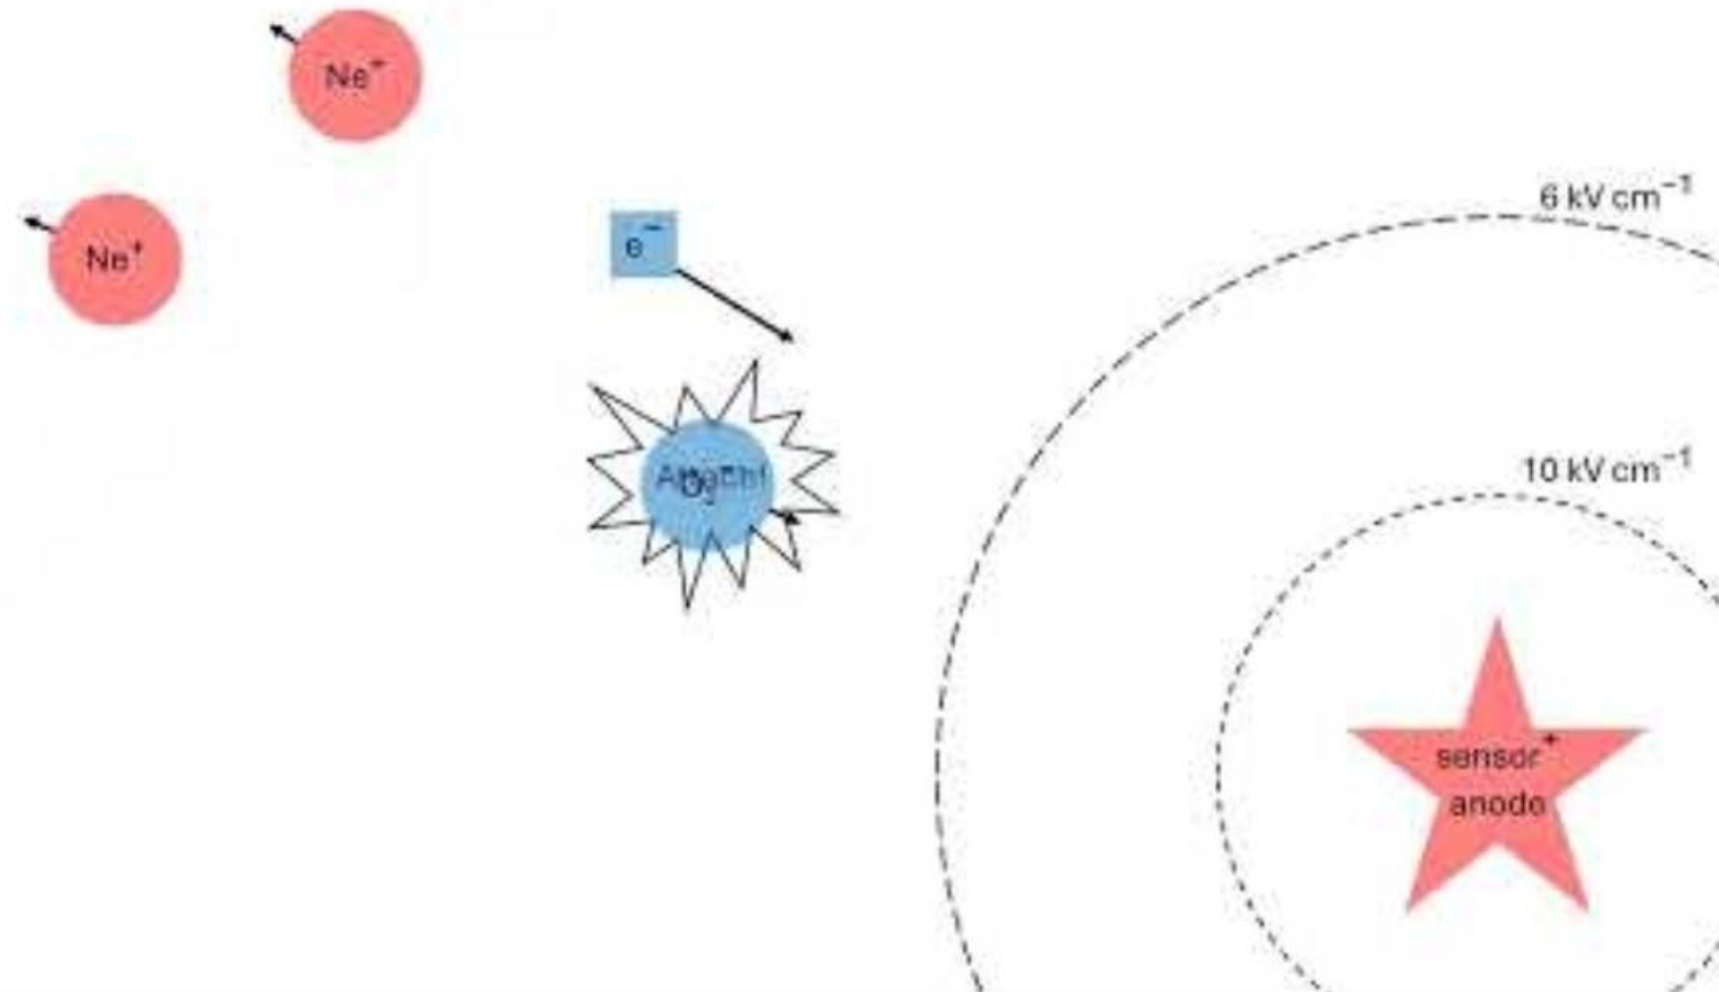
- Single electron events follow high energy alpha events
  - Rate increase from a couple seconds
- The effect increases with gas degradation (using runs with small leak in detector)
- "Single electron events" are negative ions drifting slower

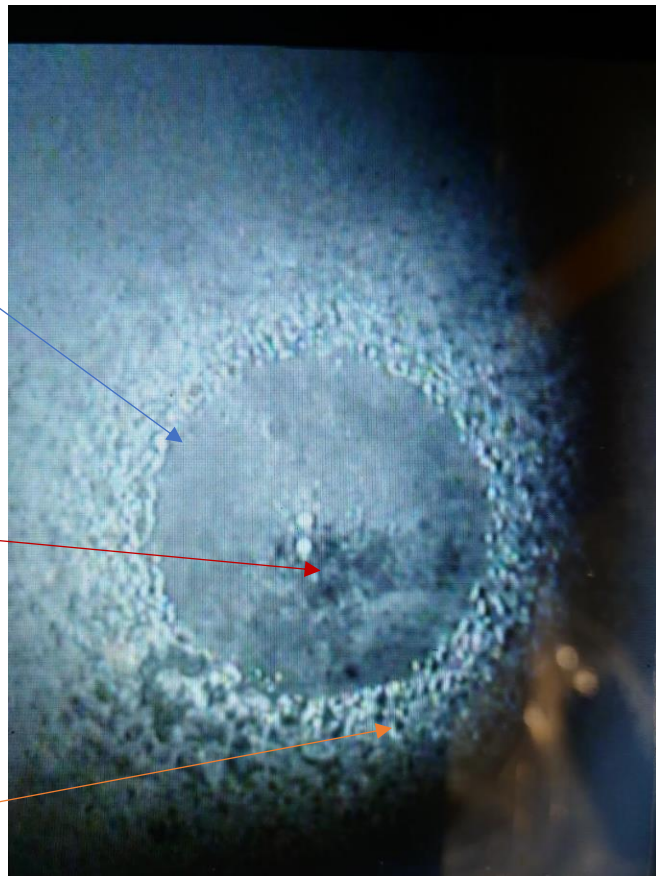
Dripping along copper nozzle, unknown origin  
No visible in stainless section

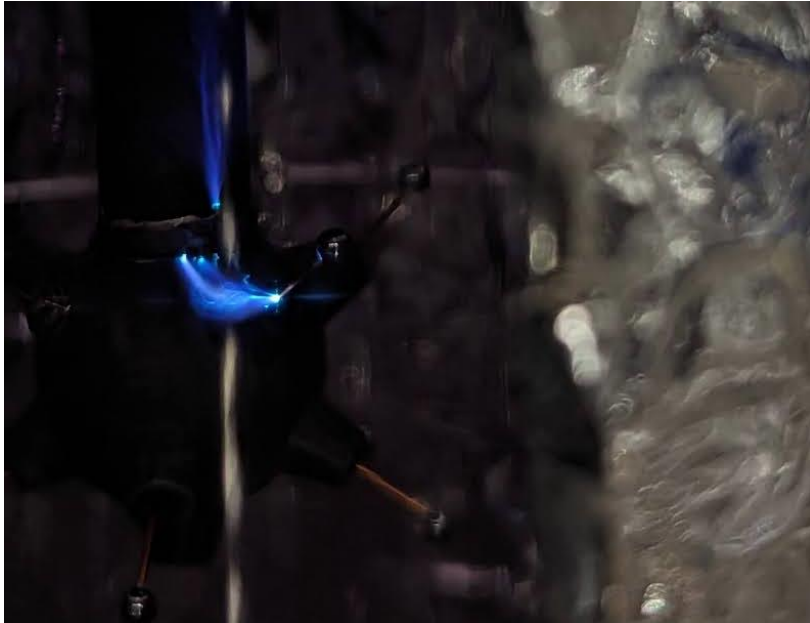
- Old sensor

- High current from  $\sim 2000V$
- Discharge from base of north wire to DLC

- Sensor replacement
  - Previous sensor unstable at high voltage
  - Problem from poorly insulated wire soldering
  - Sensors tested in transparent tube
- Better performance
  - Noise appeared after a couple months, unexplained
  - Good for alpha, cannot reach high gain
  - Possible issue with HV feedthroughs
- Alpha rate measurements
  - No significant reduction from etching
  - Dominated by radon (with surface components from daughters)

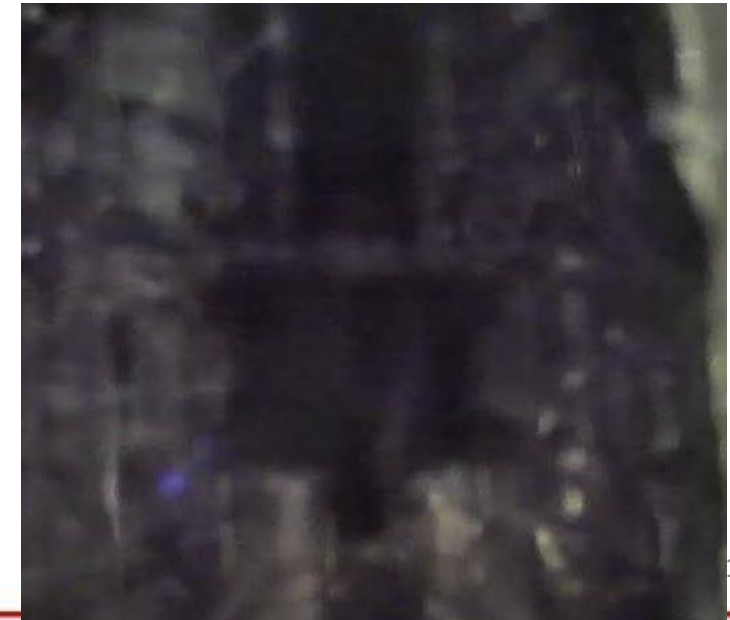
- New sensor

- Ramp to 5000V
- Discharges start at  $\sim 5000V$
- From ball to DLC, along wire
- Extra cleaning after test

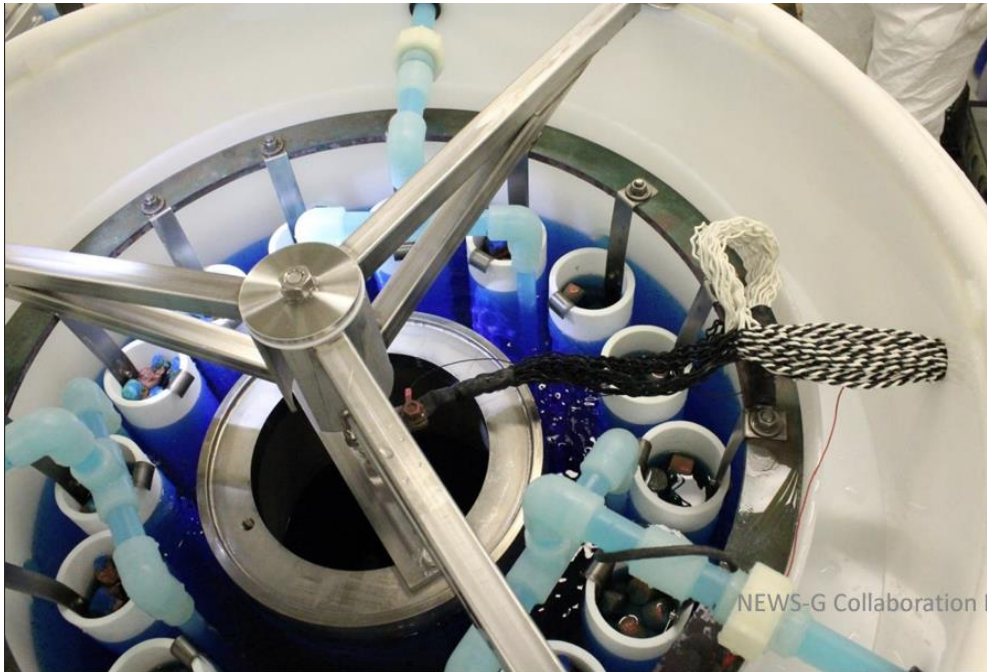
The ECA electroforming bath at PNNL

- Copper and acids samples from plating on a cylindrical mandrel reveal that lower-grade (10X cheaper) acid is viable option
- Mini-ECuME mandrel holder assembled
- Spherical acrylic mandrel was fabricated but present defects in copper non-electro forming and does not correspond to fabrication drawings
- PNNL will proceed with electroforming on spherical mandrel to learn from the experience of plating a spherical object

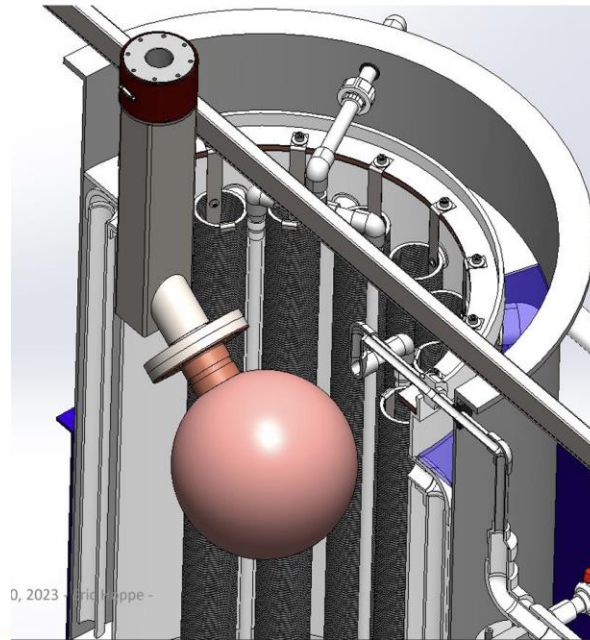
MiniECuME mandrel holder

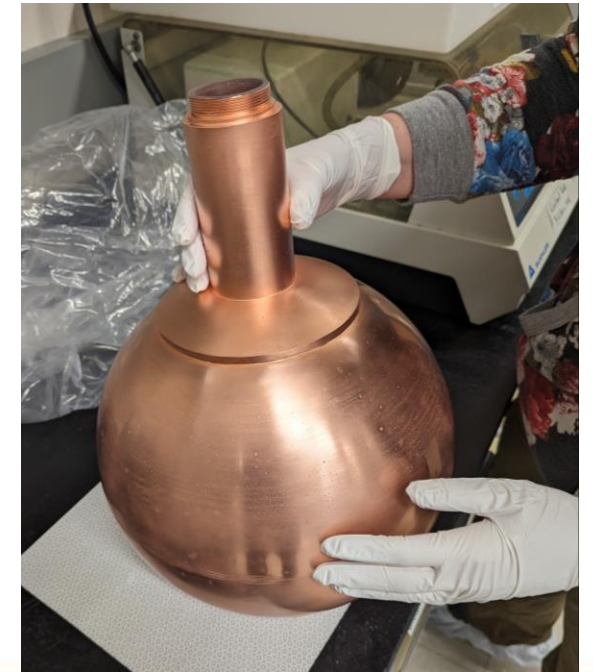
MiniECuME acrylic mandrel
